### **Appendix A – Photos of Existing Conditions in Trail Corridor**

**Appendix A**  
**Existing Conditions Main Trail Corridor – February 2009**

## *MORGAN CREEK GREENWAY Final Report*

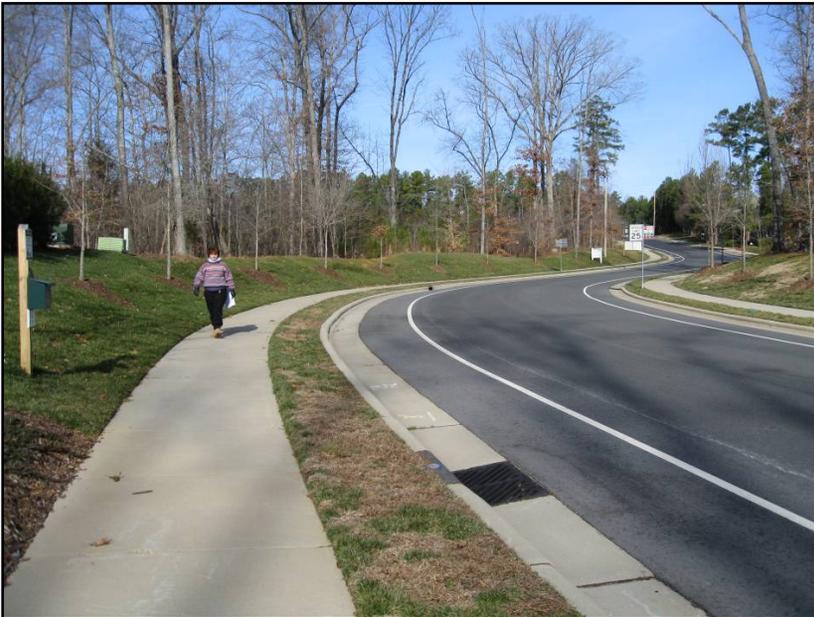
Existing sidewalks and bike lanes on Berryhill Drive.

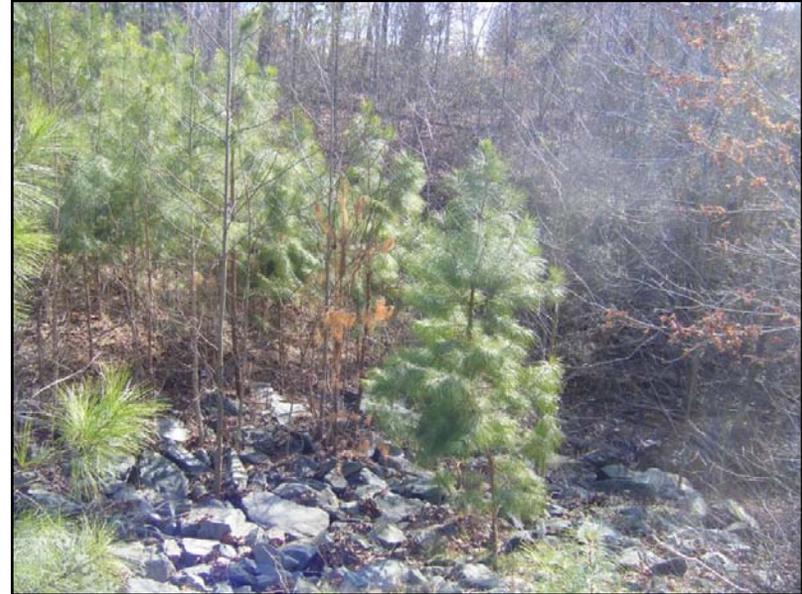
Steep rocky drainage way from UNC Park and Ride lot.

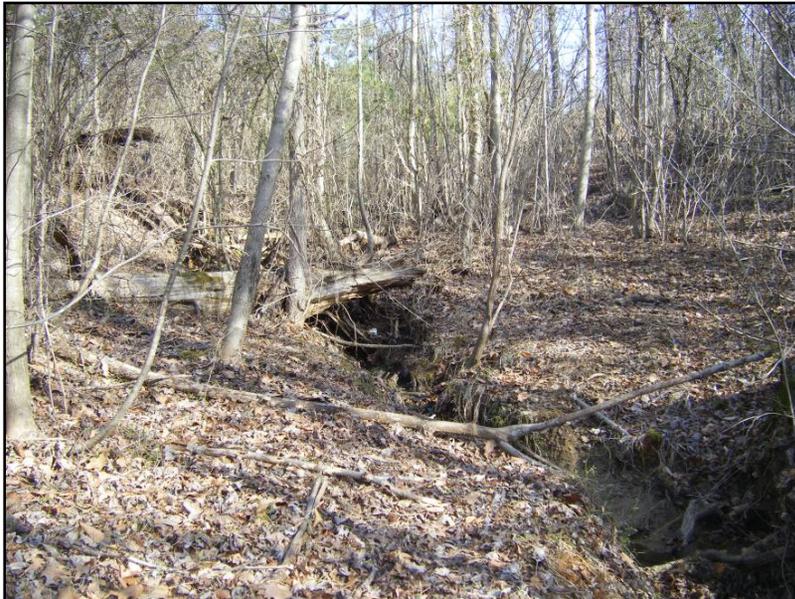
There is space along Berryhill Drive to expand the existing walkway to create a 10' wide trail profile. There is space behind the Rosewalk townhouse development for a trail to be installed, but the terrain is generally steeper than would accommodate an accessible route, and there is a jurisdictional stream there so stream buffers would need to be respected.

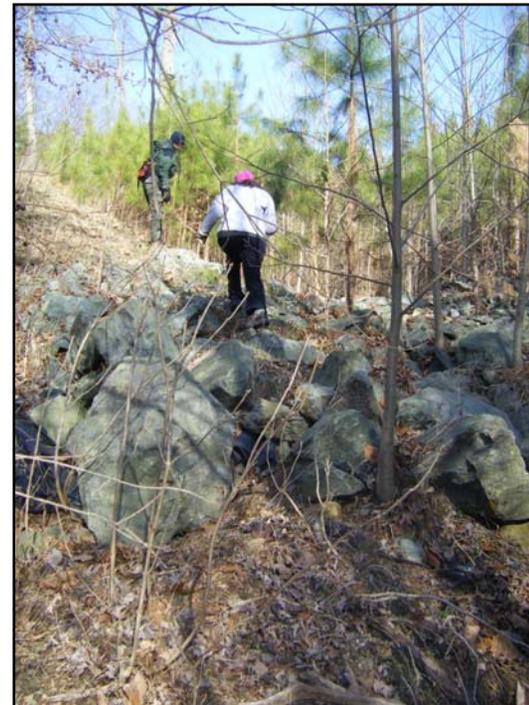
Existing stream channel behind the RoseWalk Development on Berryhill Drive.

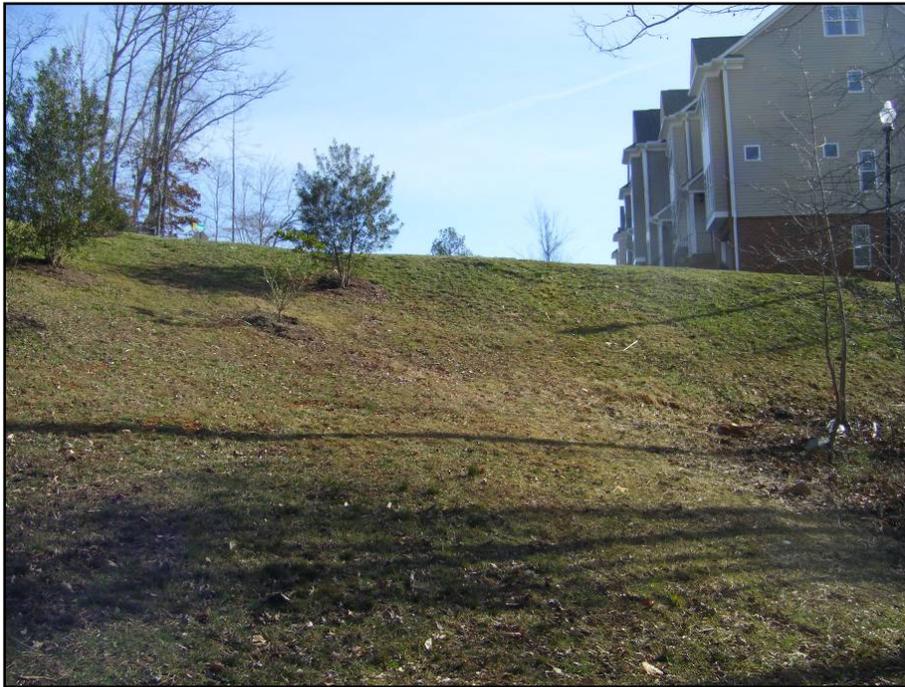
Slope from the north end of the Rosewalk townhome site to the existing gravel trail.

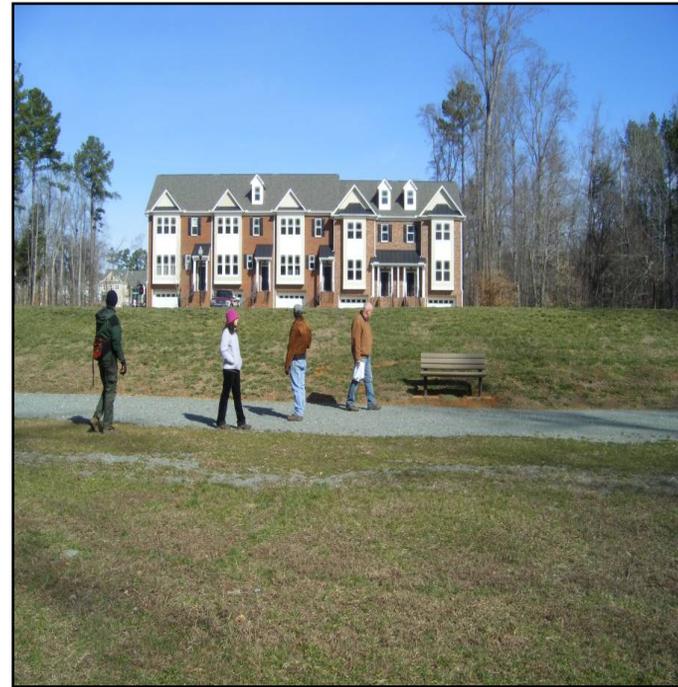
Existing gravel trail at the south end of the Rosewalk townhome development.

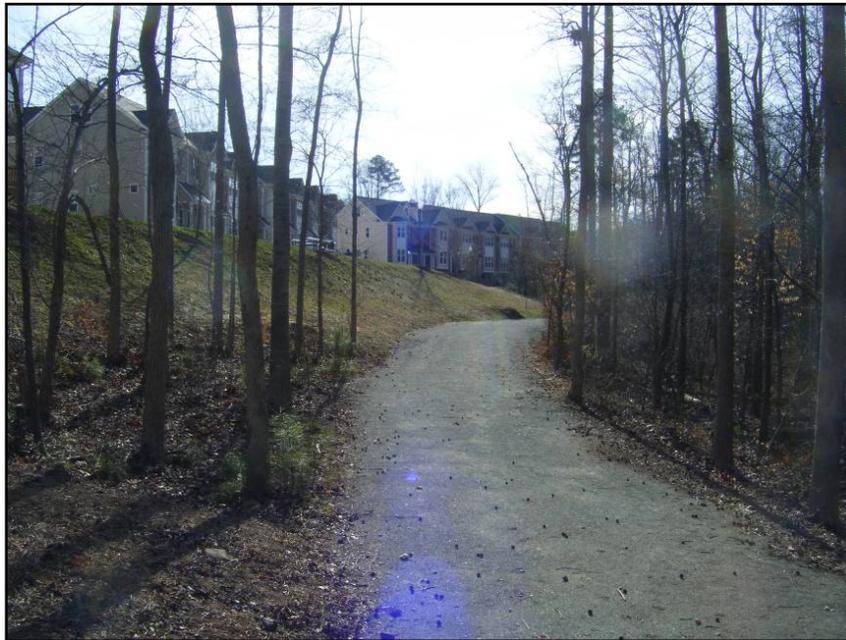
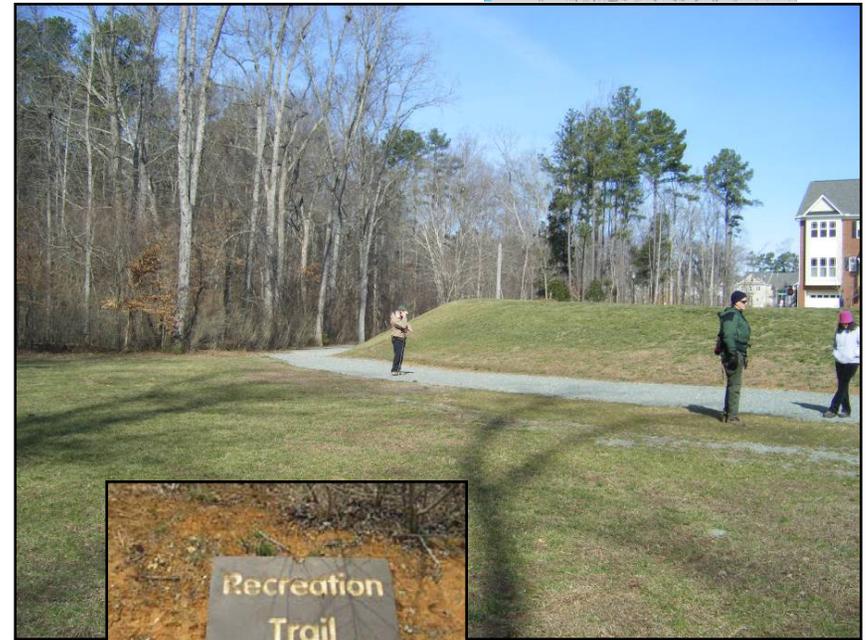
Existing 10' wide gravel trail along the west and south edges of the Rosewalk townhome development.

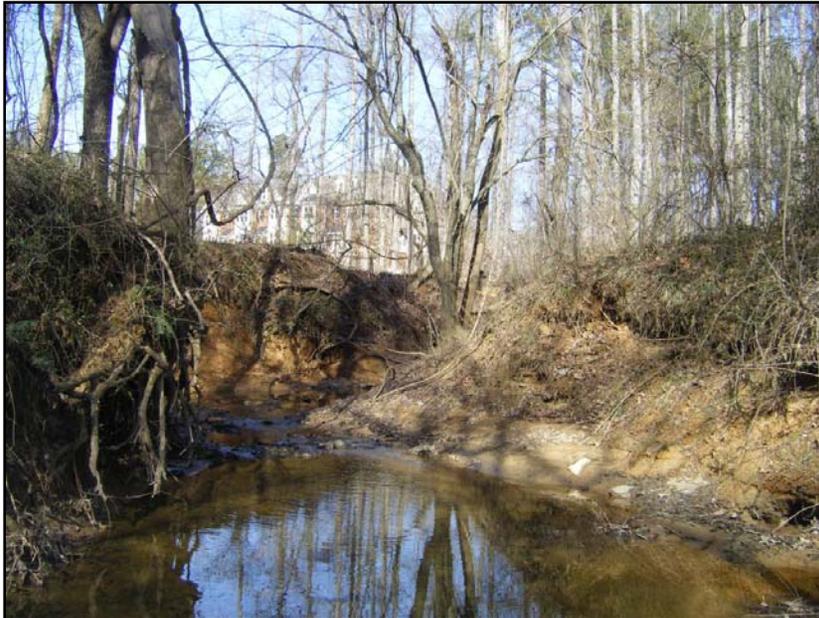
A typical section of Tom's Creek dividing the Rosewalk townhome community and the Chapel Hill Tennis Club properties.

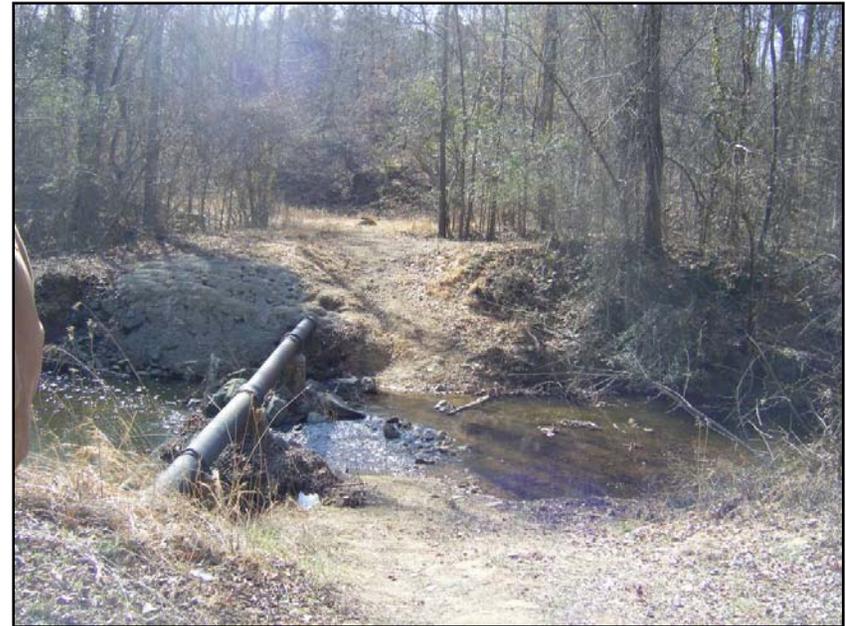
Intersection of Morgan Creek where Tom's Creek flows into it. The slopes are flat enough that any crossing at this point would be a very long bridge. Also there is a sewer line crossing the creek here and other debris type obstacles in Morgan Creek. The stream banks are not stable, which presents problems for stability of bridge abutments.

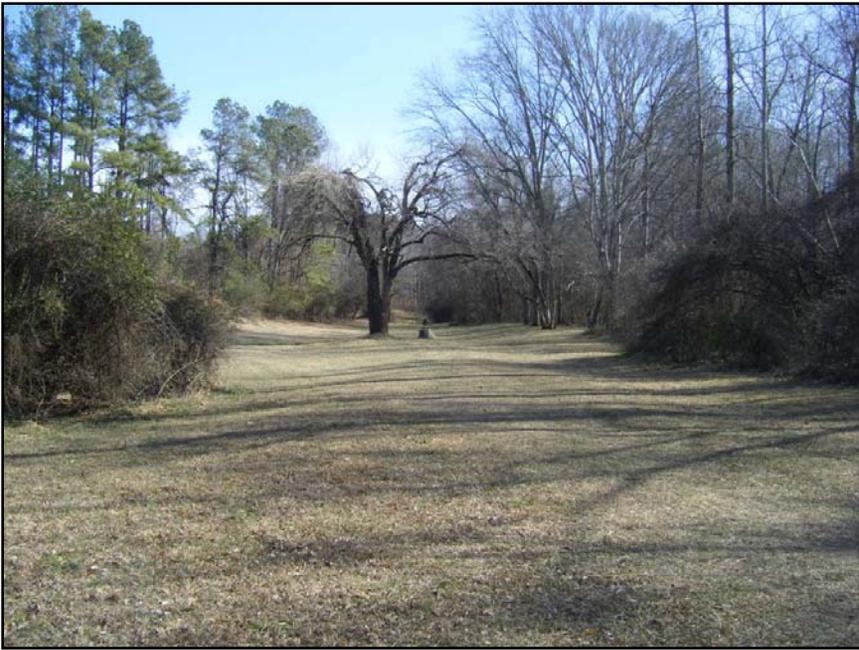
Looking east along the south end of the Chapel Hill Tennis Club property. There is a sanitary sewer main along the left side of the clearing. The left side of this area is an existing greenway easement.

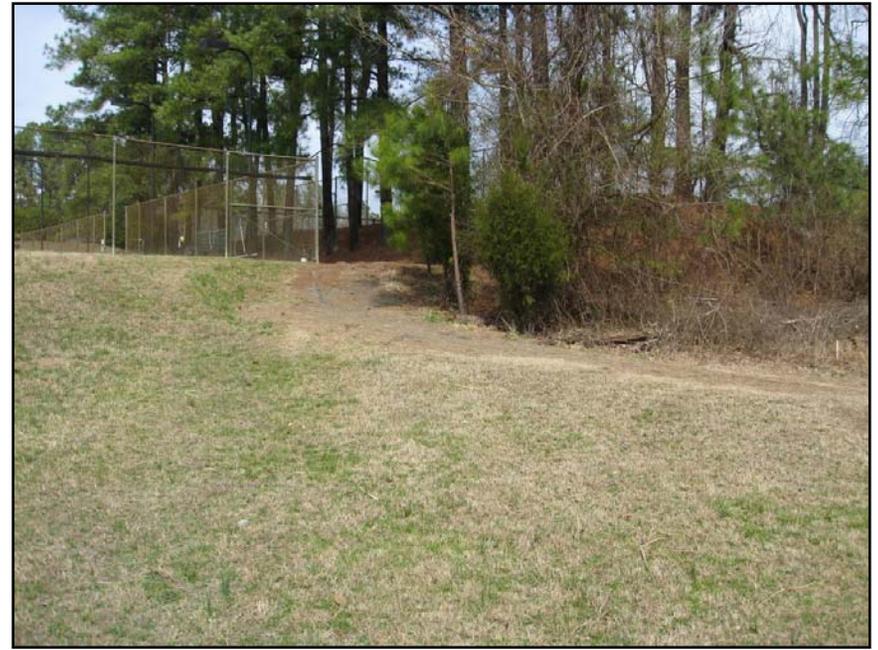
There are already informal footpaths from the proposed trail area and creek to the Tennis Club facilities.

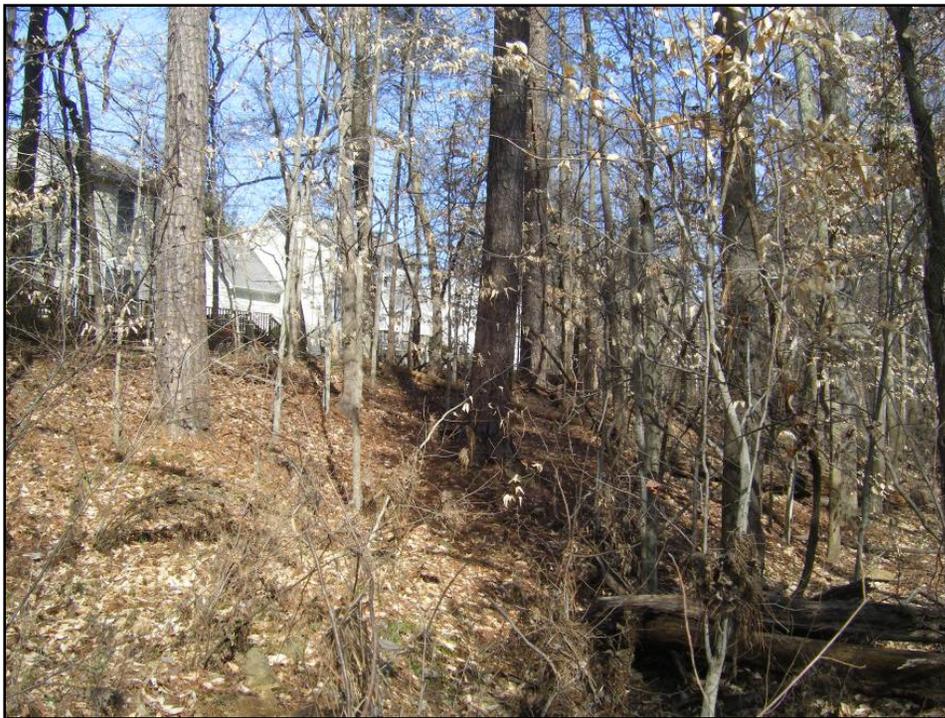
Chapel Hill Tennis Club property behind the Weatherhill Pointe homes.

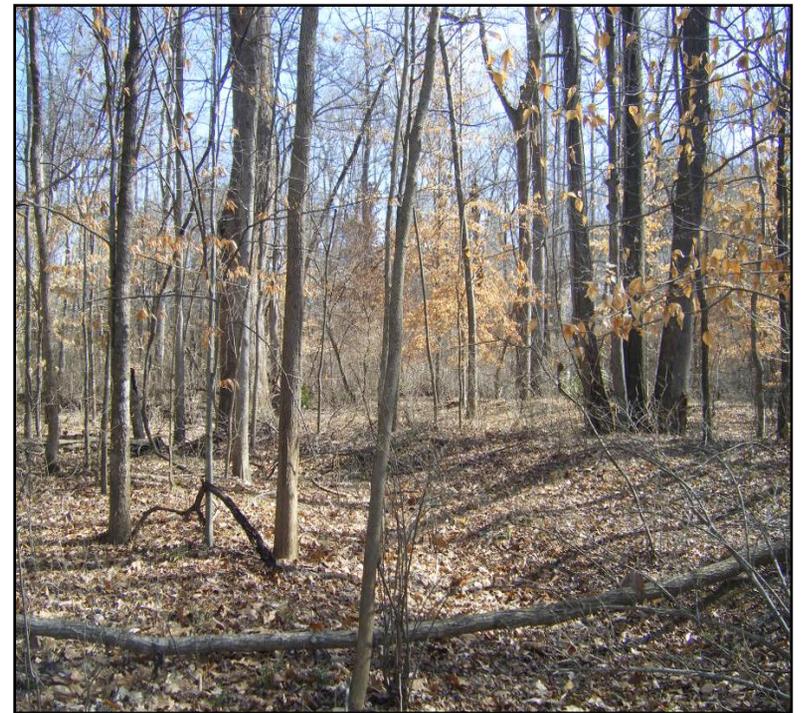
Forested greenway easement area on the tennis club property between Weatherhill Pointe and Morgan Creek.

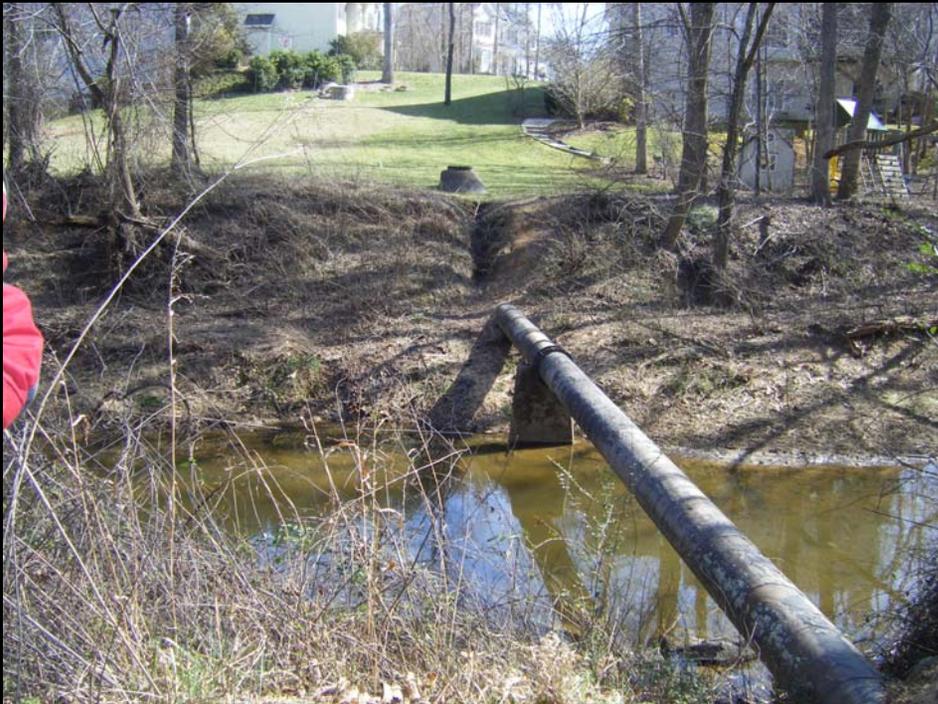
Looking across Morgan Creek from Weatherhill Pointe to the Berryhill community. Across the creek to the left is the southern edge of the property owned by the Town of Carrboro. Homeowners have encroached slightly into Town owned property.

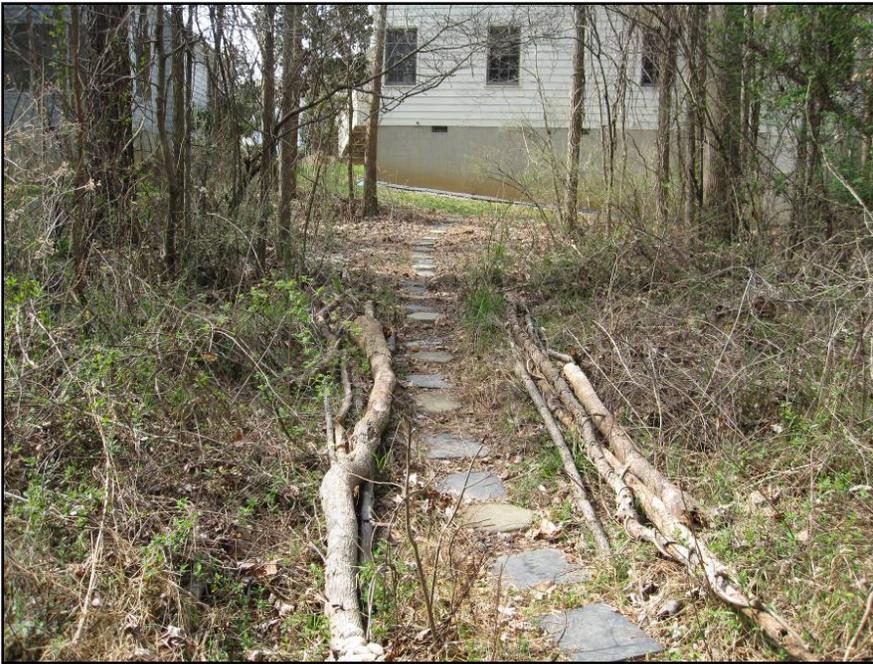
An informal connection between the homes at Weatherhill Pointe and Morgan Creek.

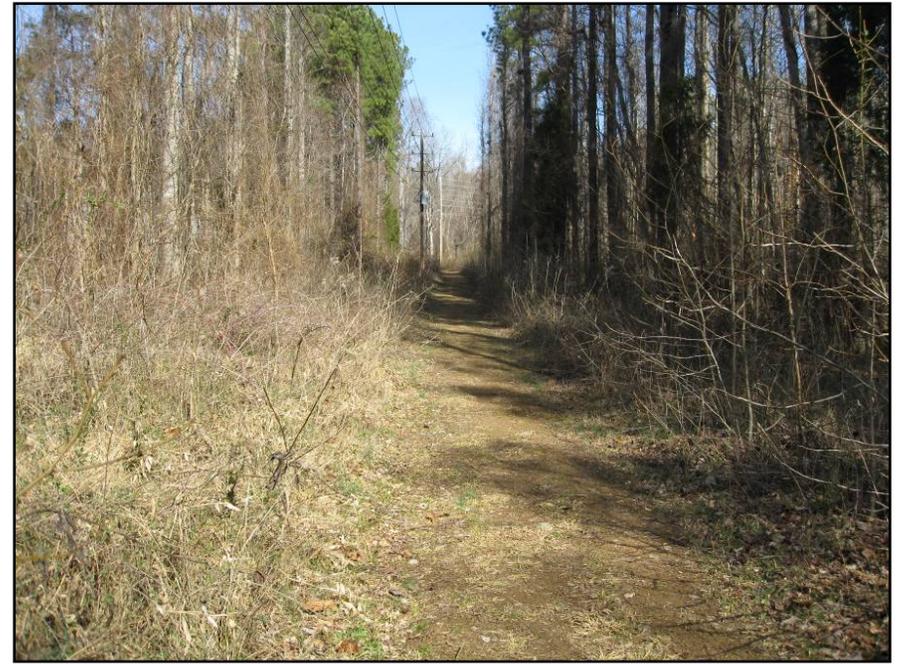
A Piedmont Electric service line running parallel to Morgan Creek between Weatherhill Point and the creek. Piedmont Electric has indicated they would allow a paved trail under this service line.

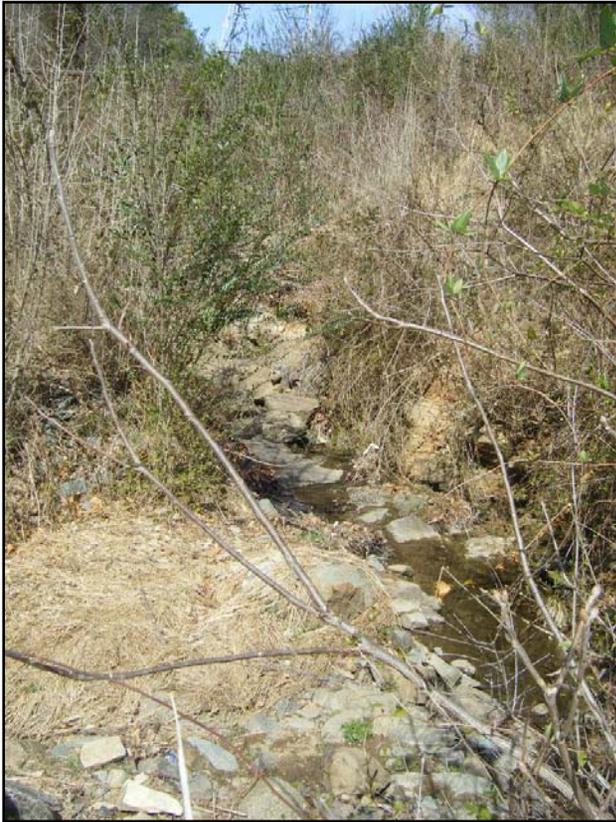
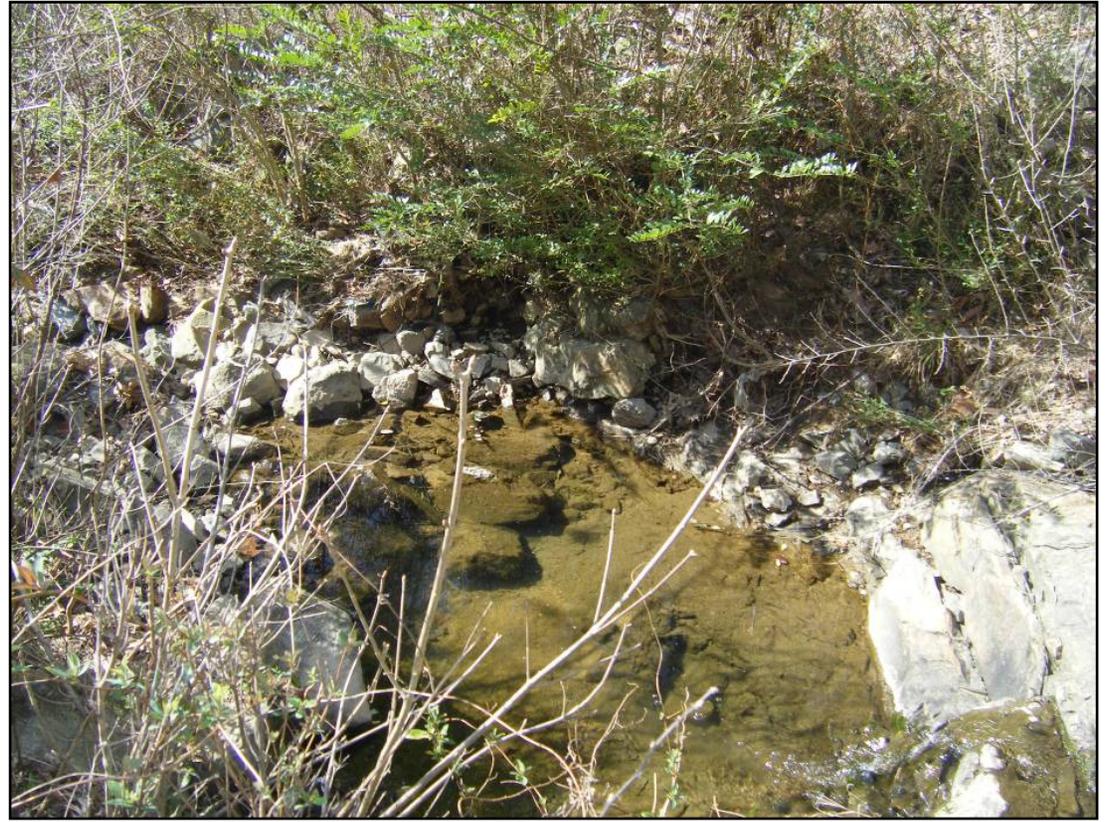
Drainage way between Westbrook Drive and Morgan Creek. Slopes here are moderately steep. The drainageway is not in the floodplain.

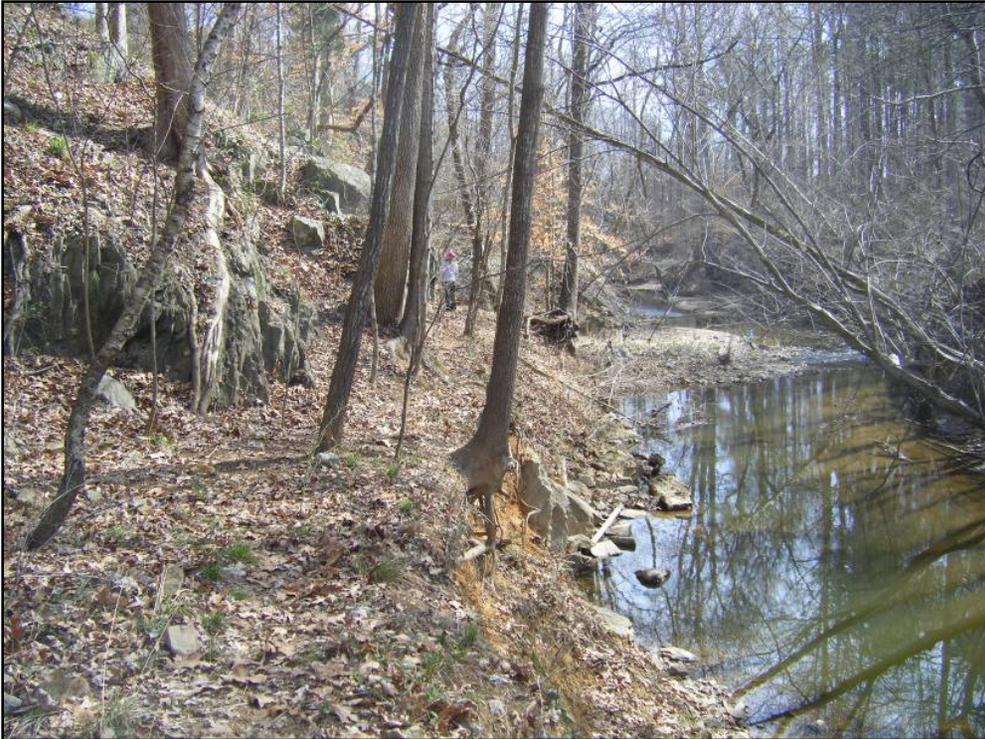
Morgan Creek looking east at the base of the steep slope from Hwy 54 on the PEP Holding properties. At the west edge of the steep slope area there is a small “shelf” adjacent to the creek. It is in the FEMA mapped floodway. Slopes are extremely steep.

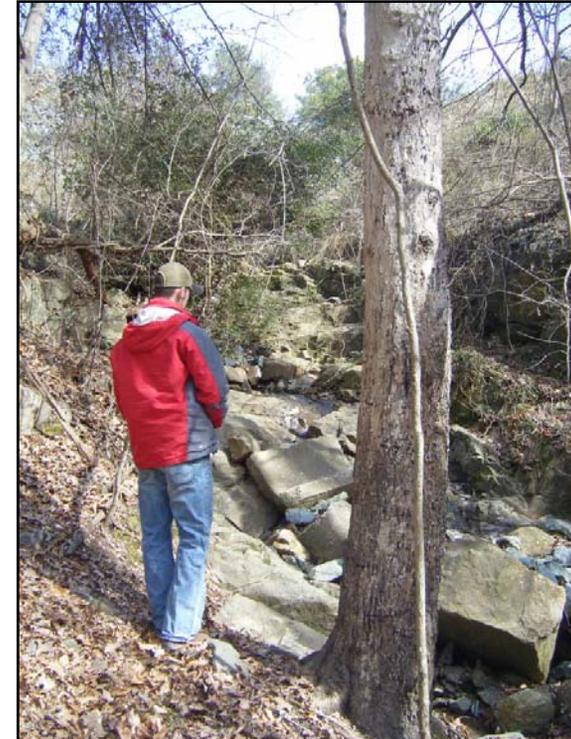
There is a lot of construction debris on the slope from Hwy 54. This area of debris is in a drainageway from the highway and concrete waste has been used with the rip rap for bank stabilization.

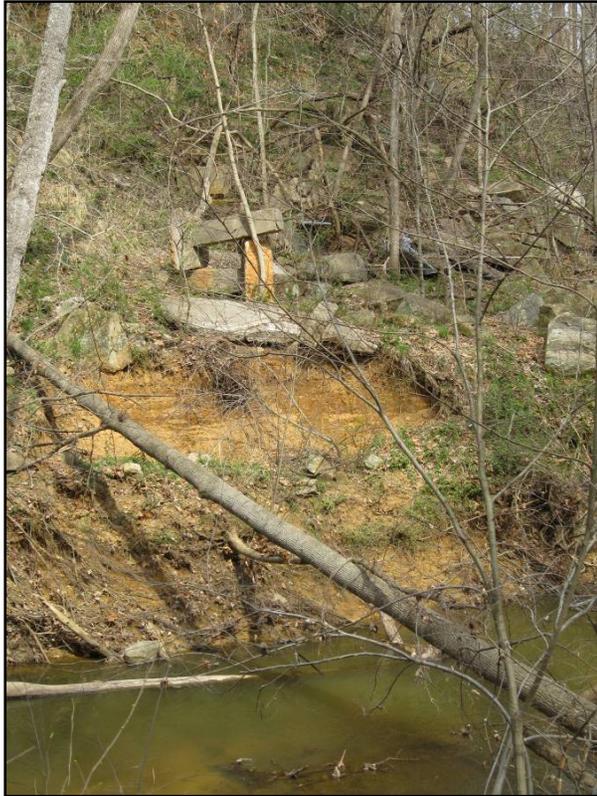
Construction debris from past highway widening on the steep slopes below Hwy 54. This is the north streambank of Morgan Creek.

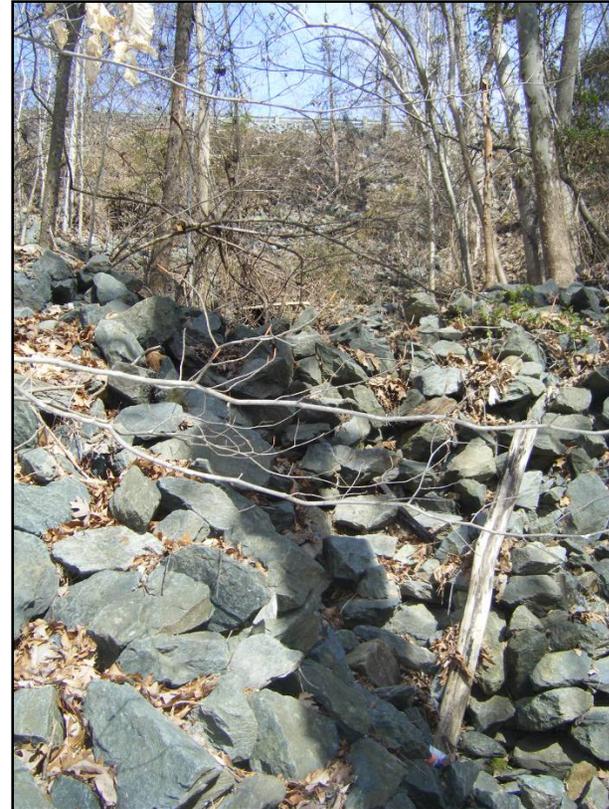
Rip-rap storm drainageways from Hwy 54 (guardrail on the highway is visible at the top of the photo).

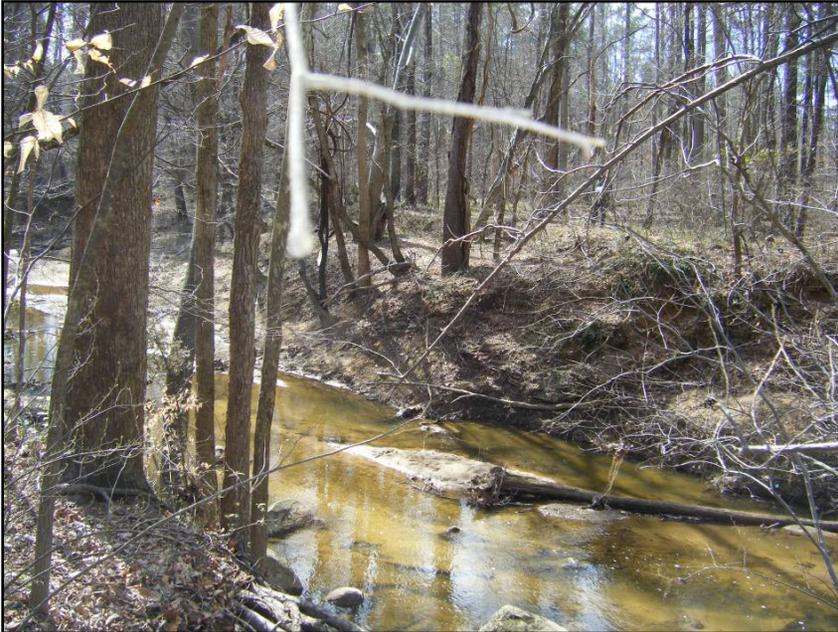
View of the Town-owned land on the south side of Morgan Creek across from the PEP Holding steep slope areas.

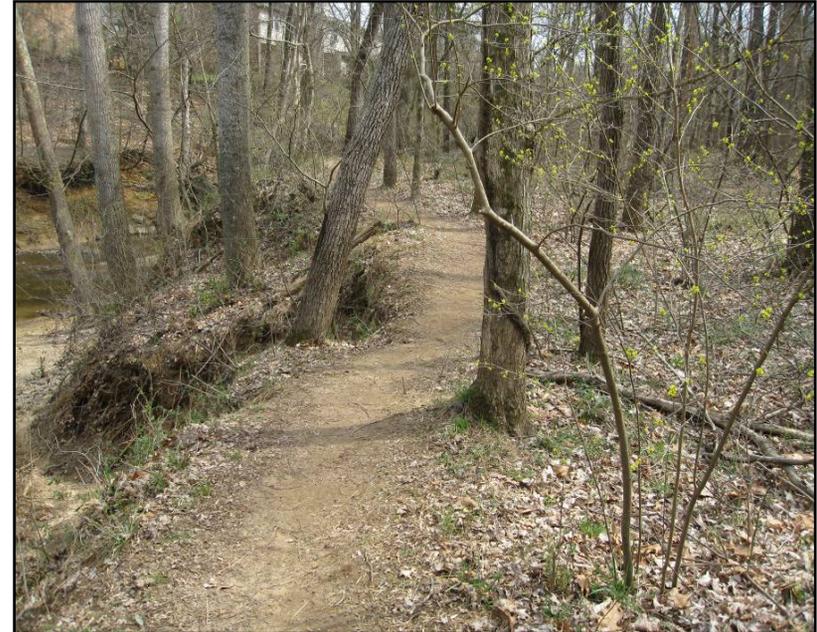
Informal footpaths through the Town-owned land on the south side of Morgan Creek north of the Berryhill community.

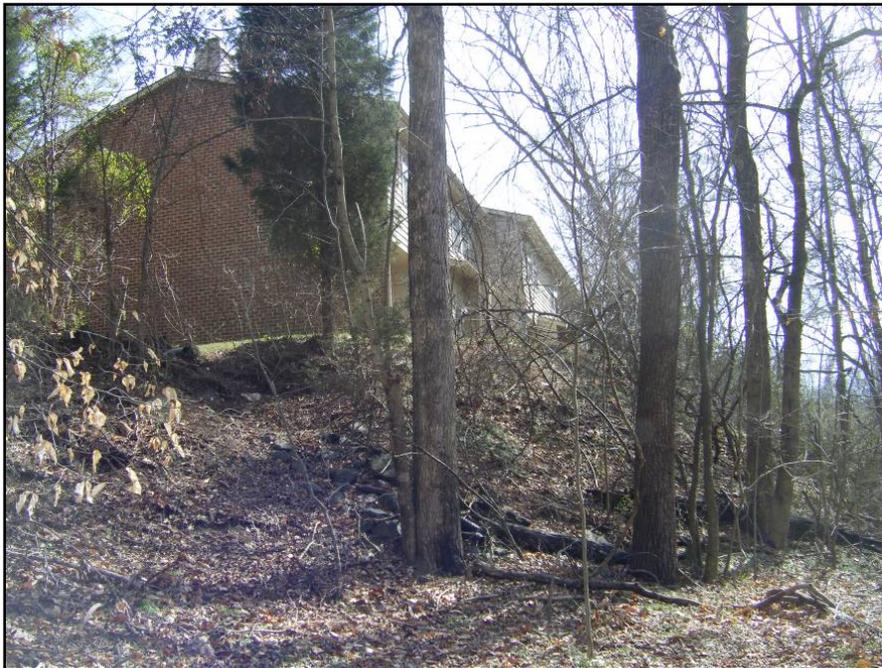
Canterbury Townhouse Property, north side of the creek.

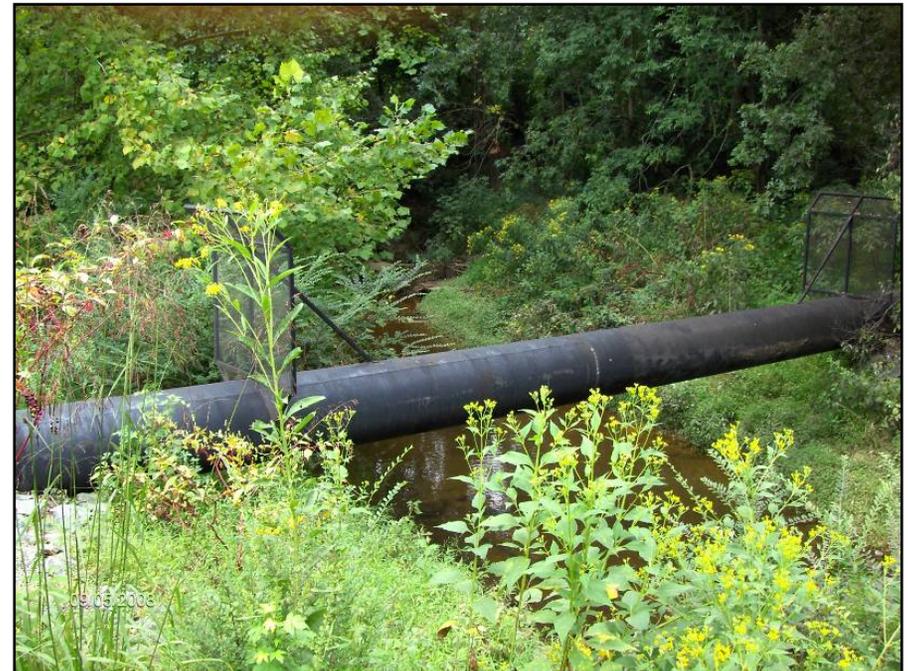
Existing OWASA sanitary line crossing Morgan Creek at the south end of the Canterbury Townhouse community. OWASA has added fencing to each side of the line to discourage pedestrian crossing.

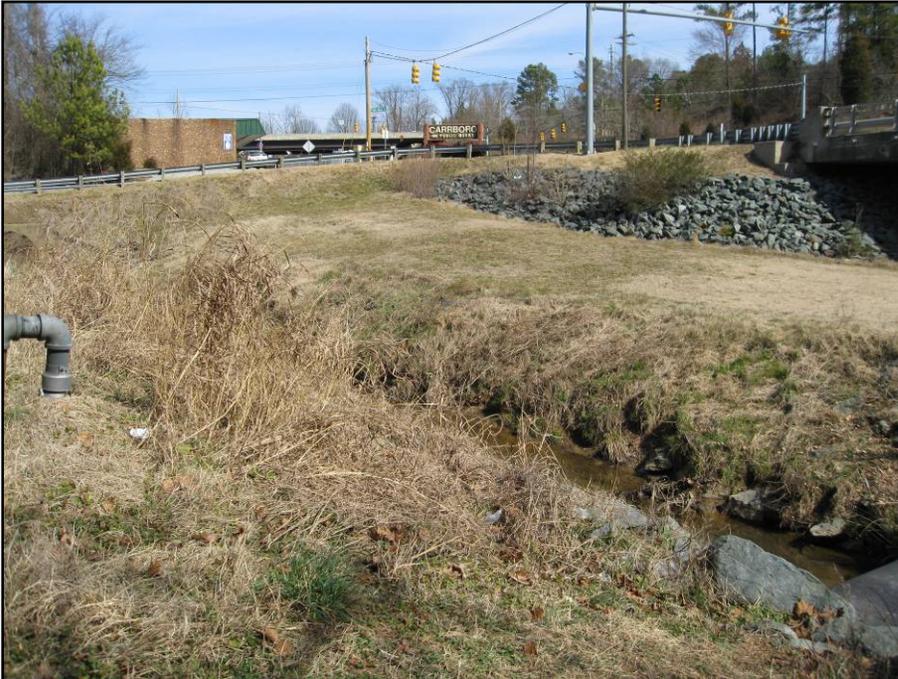
Driveway access to the Town property and drainageway in front of the Town of Carrboro Public Works site near the Smith Level Road bridge.

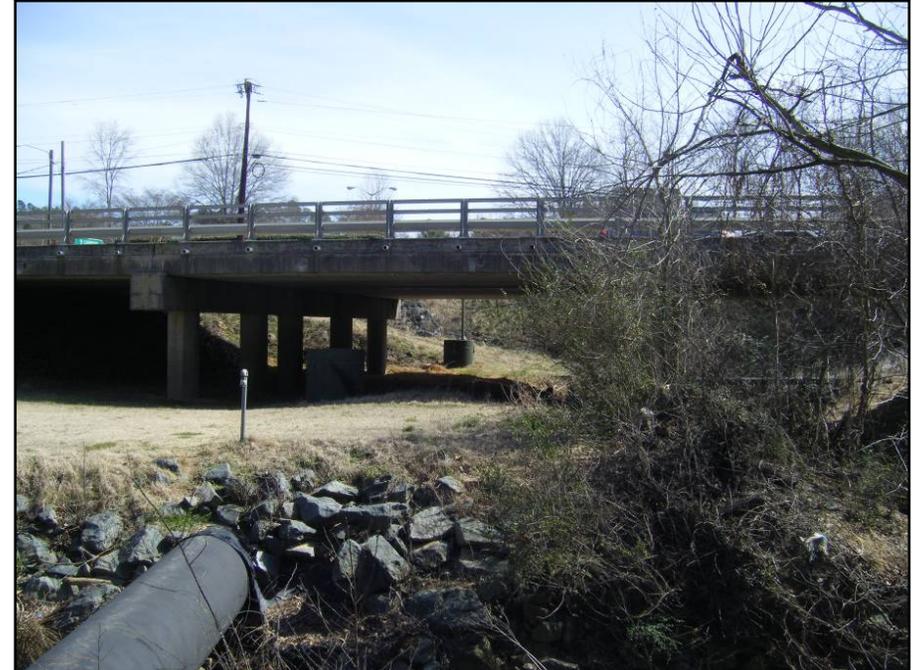
View from the Carrboro Public Works facility toward Smith Level Road on the north side of Morgan Creek. The proposed Town of Chapel Hill trail is planned to end on the other side of the bridge, on the north side of the creek.

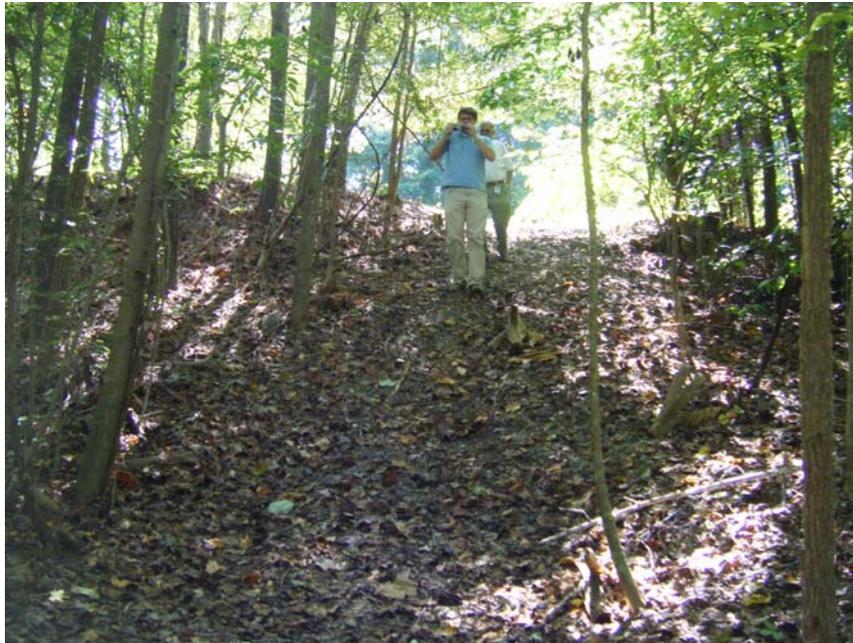
Steep slope between the south bank of Morgan Creek and the end of Tar Hill Road.

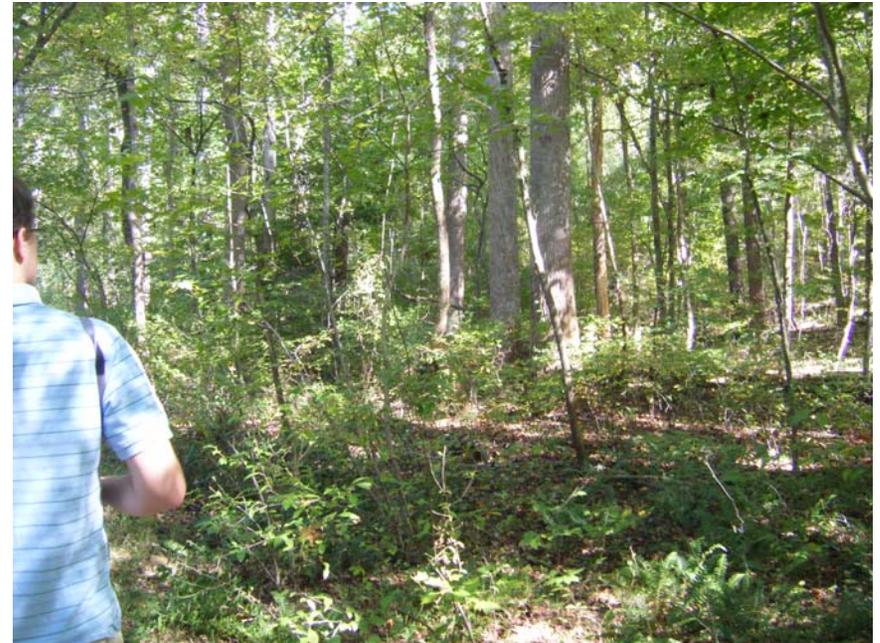
Understory and ferns in wooded area on the south bank of Morgan Creek near Tom's Creek.

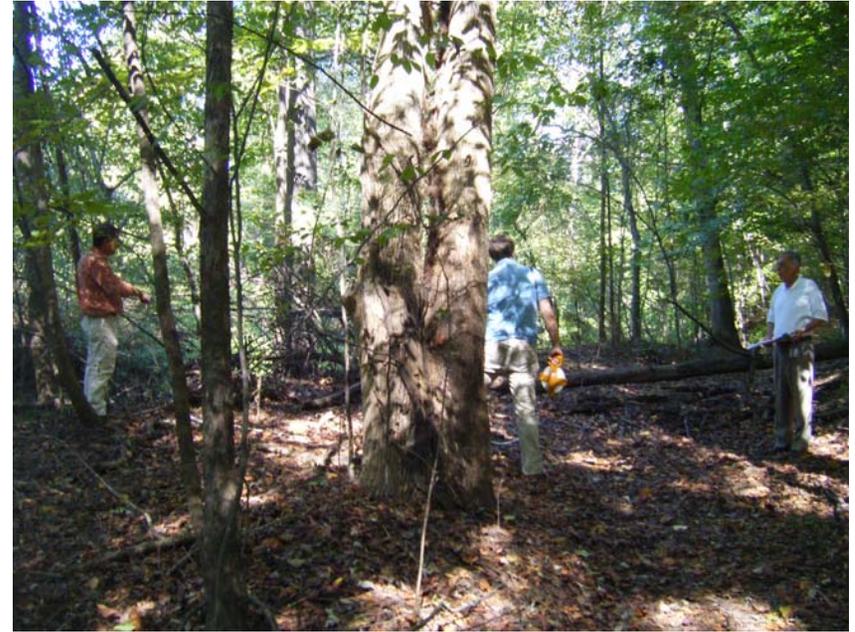
Bench at top of bank on south side of Morgan Creek east of Tom's Creek.

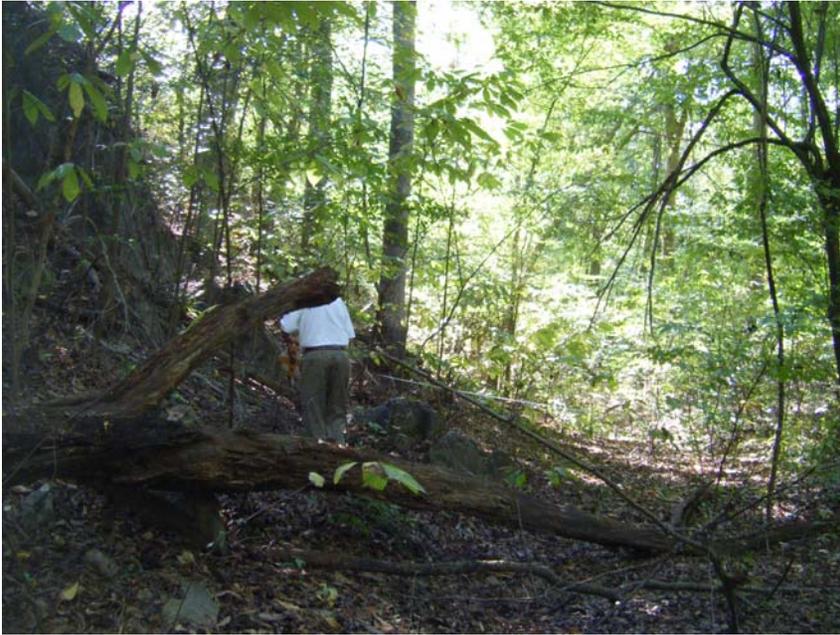
Western edge of Triangle Land Conservancy property.

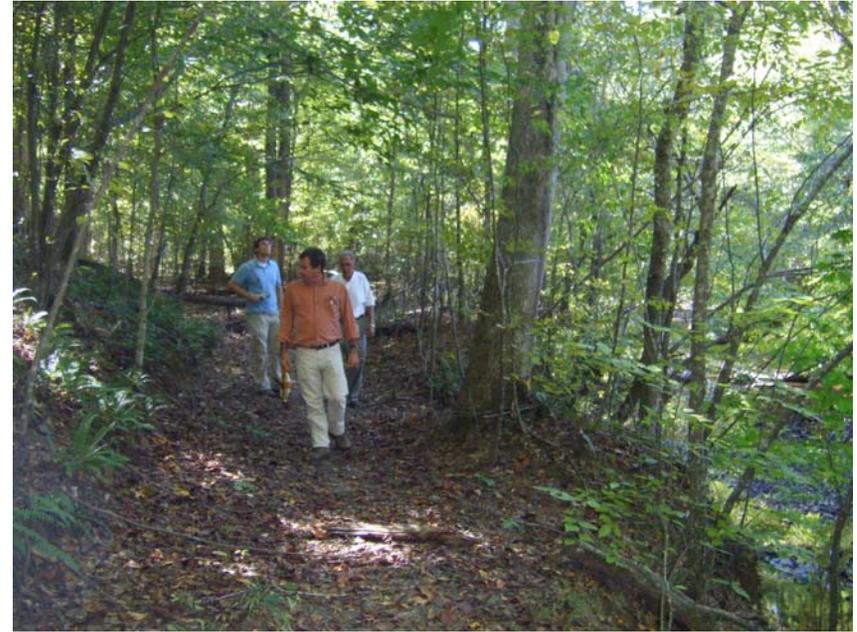
The terrain is getting steeper and more rocky.

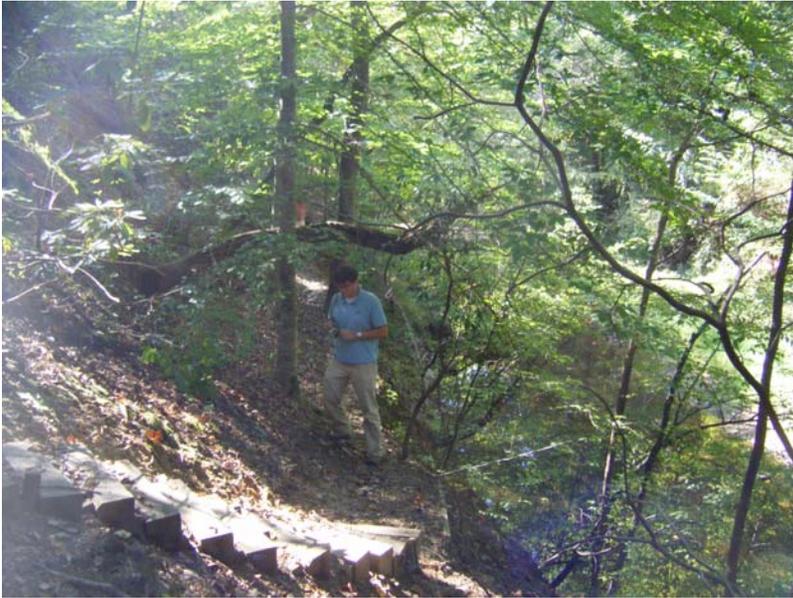
By the east end of the Triangle Land Conservance property, there is almost no bench at the top of bank and the terrain becomes steeper. Streambanks in this area are somewhat unstable from erosion.

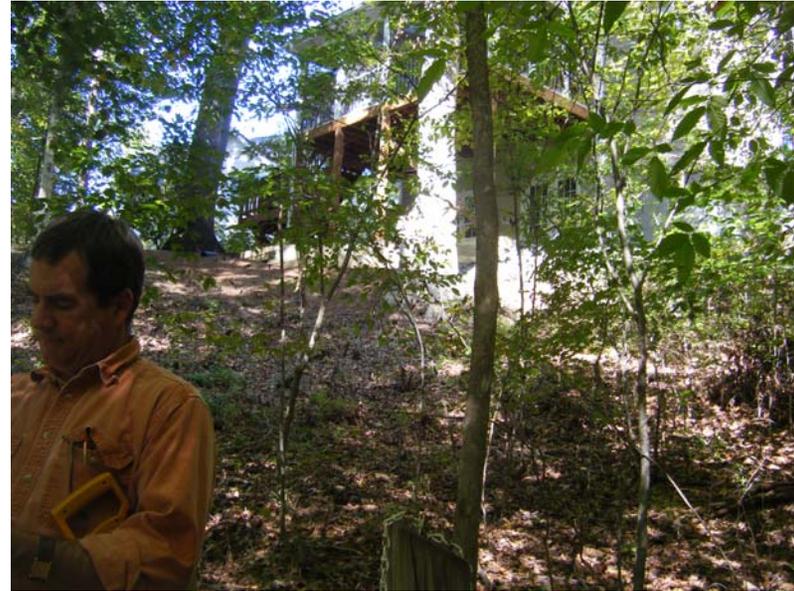
There are homes at the top of bank in the Berryhill neighborhood.

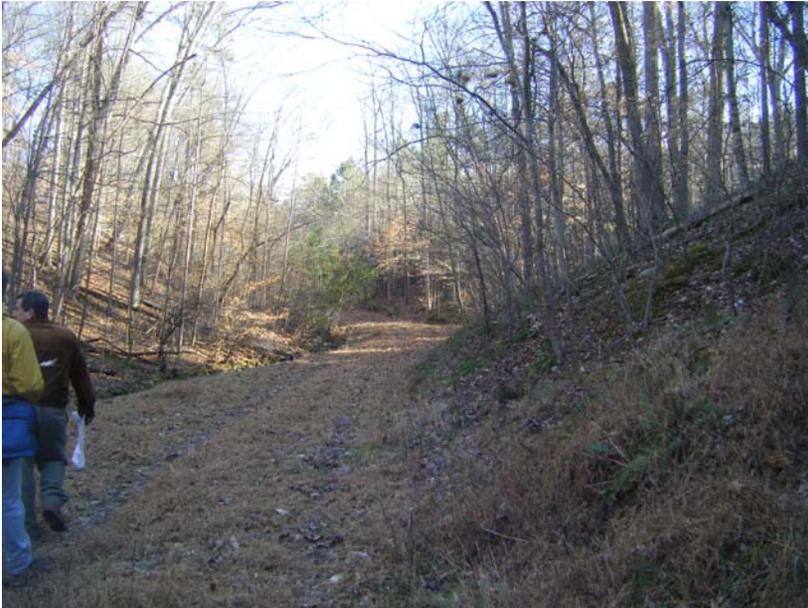
Drainage way and OWASA easement south of Morgan Creek and east of Tar Hill Drive.

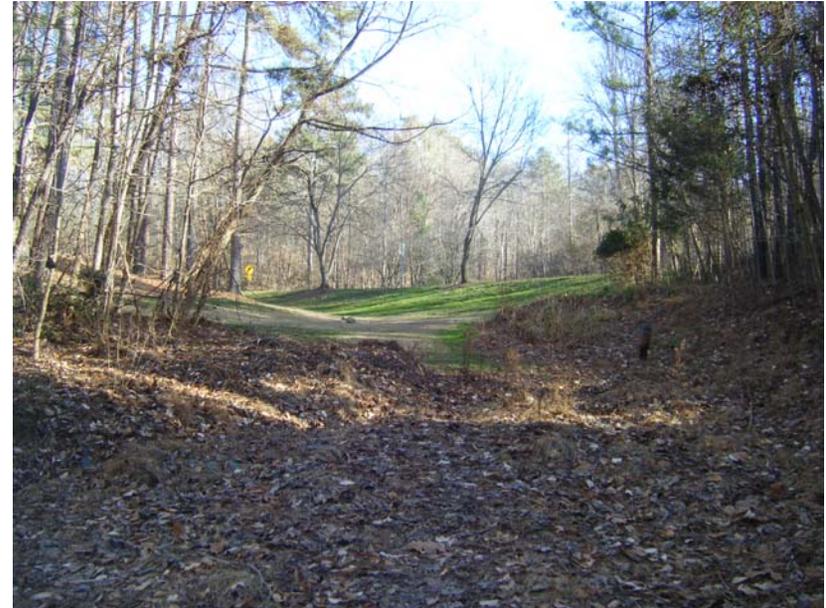
The same drainage way at the approach to BPW Club Road.

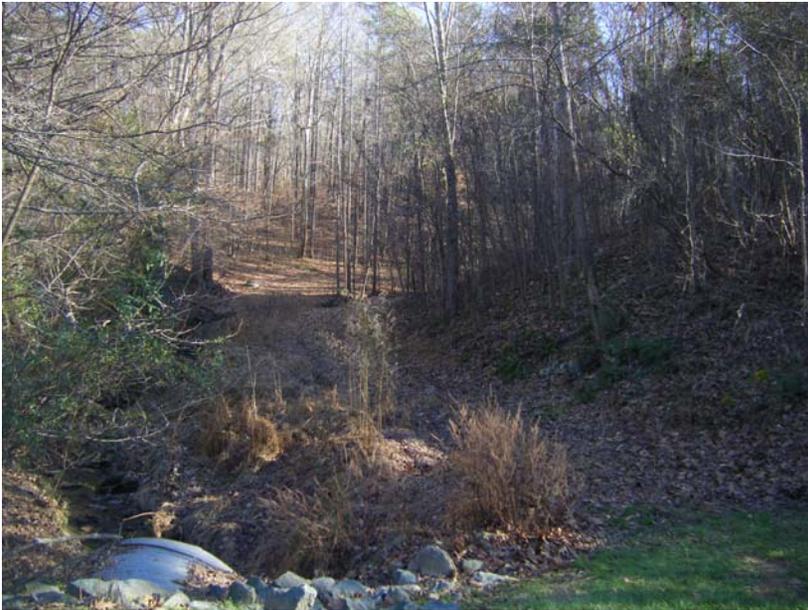
OWASA easement on north side of BPW Club Road.

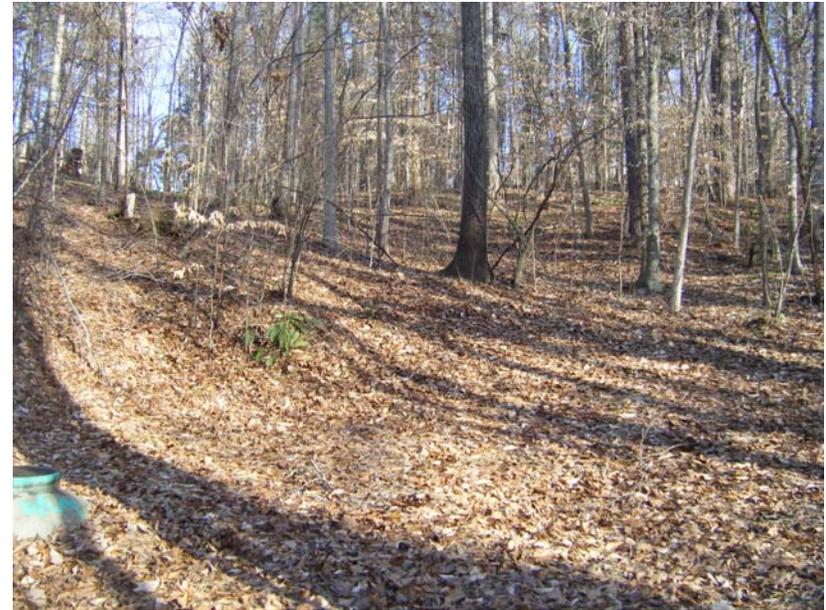
Gentle slopes from OWASA easement to Villages of Chapel Hill apartment complex.
