### **Appendix A – Photos of Existing Conditions in Trail Corridor**

**Appendix A**  
**Existing Conditions Main Trail Corridor – February 2009**

## *MORGAN CREEK GREENWAY Final Report*

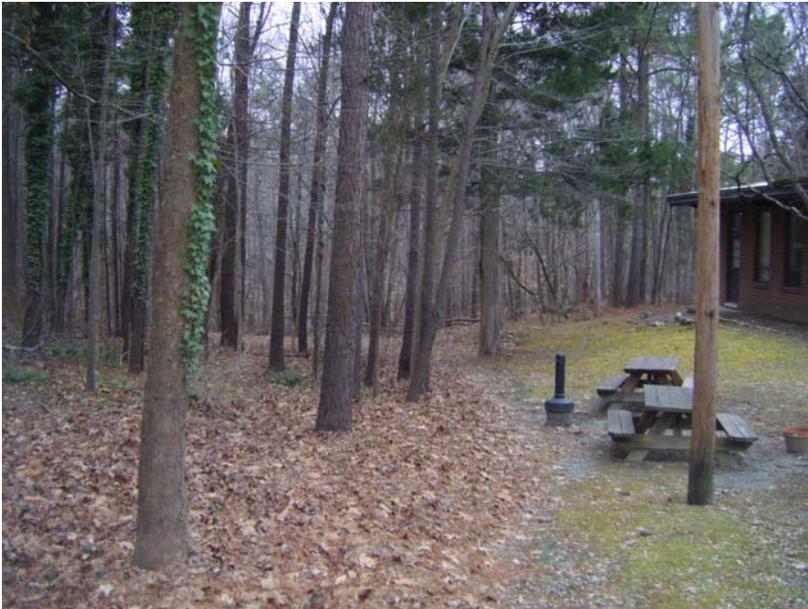
Wooded gentle slopes between the OWASA easement and the BPW Club on BPW Club property.

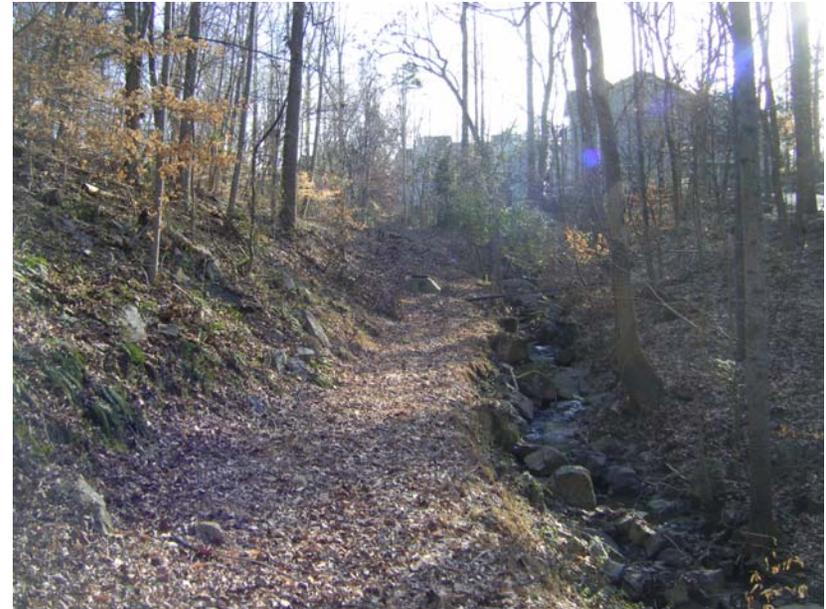
Steep stretch of OWASA easement approaching Villages of Chapel Hill driveway.

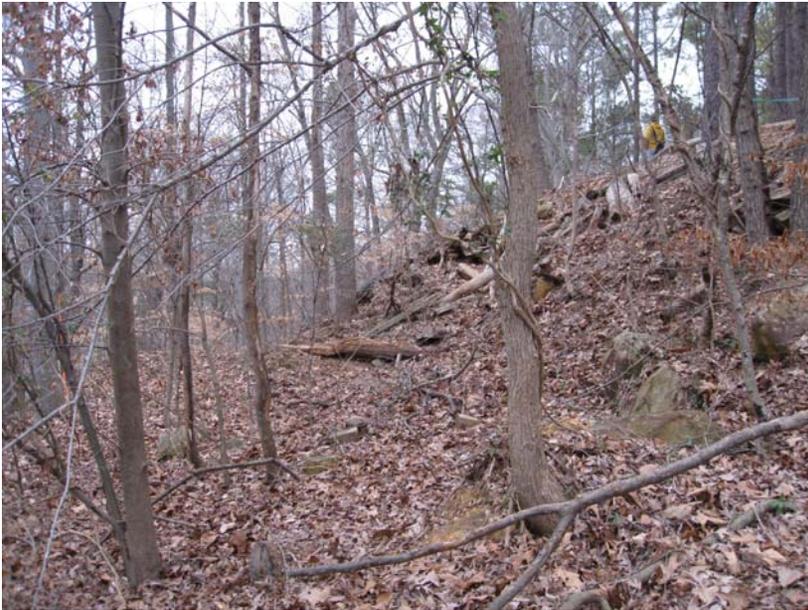
Steep slopes between Villages of Chapel Hill and Rock Creek Apartments.

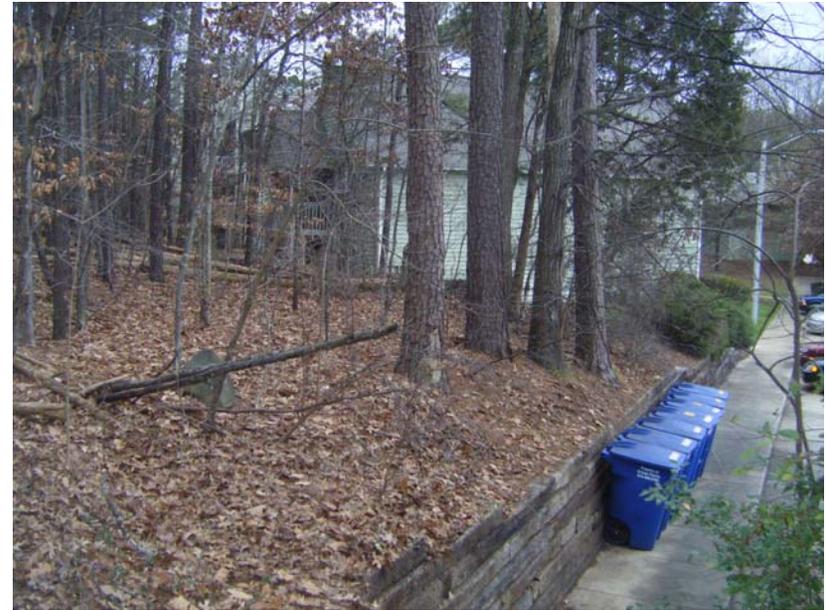
Access possibilities on Rock Creek Apartment property.

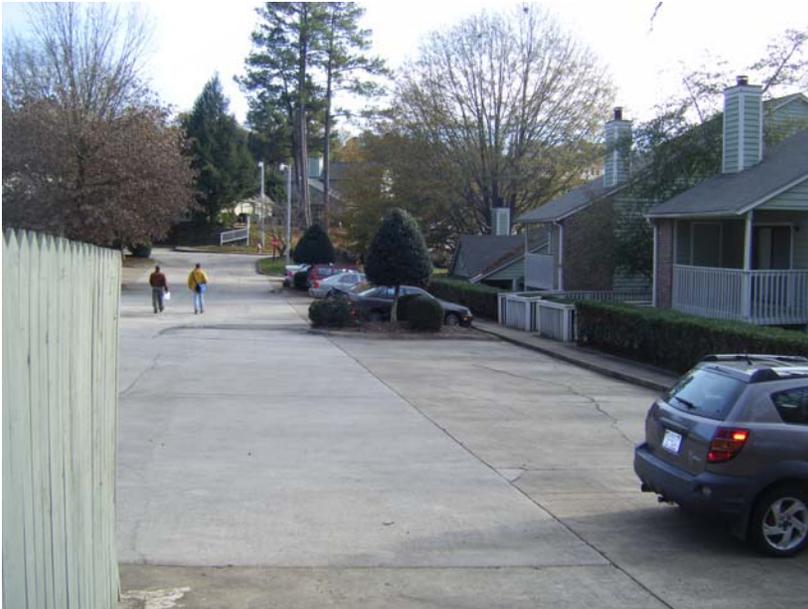
Parking lot at Rock Creek Apartments approaching Rock Haven Road.

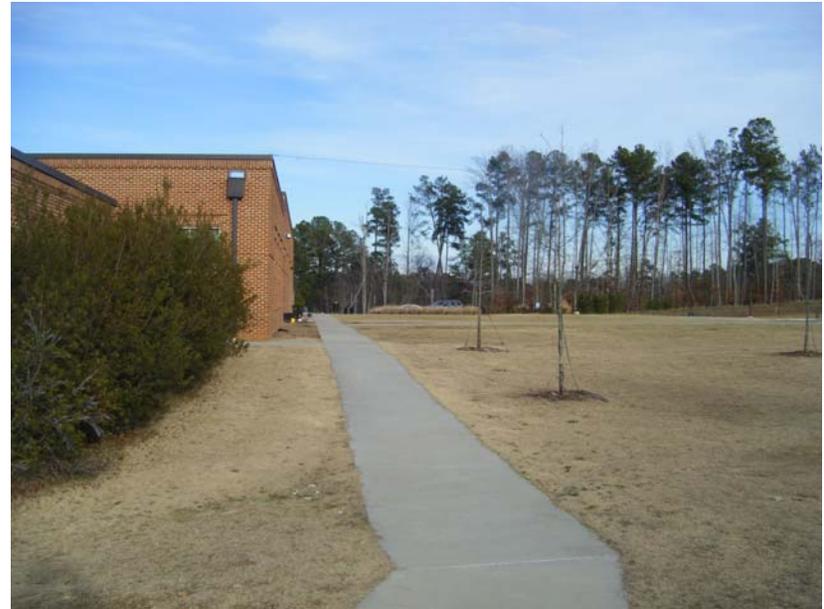
Flat area around Carrboro High School building.

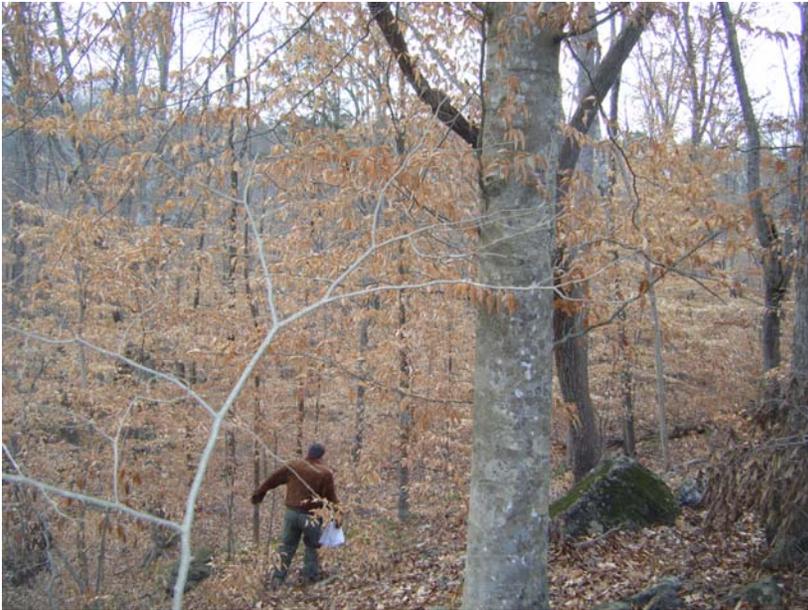
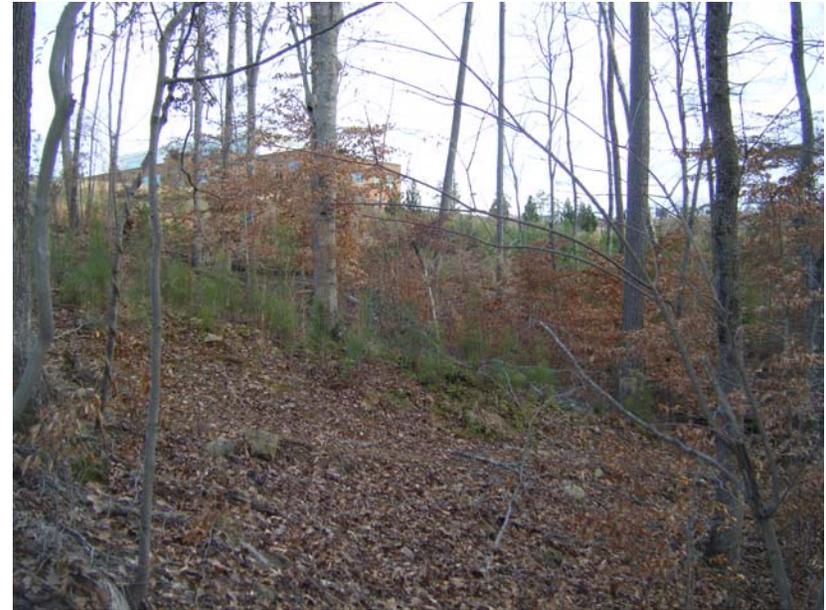
Steep slopes on high school parcel northwest of school building along stream.
