Appendix 3A. Carrboro Bolin Creek Sites, June 2012

Bolin Creek sites are numbered from most upstream (Site 1) to most downstream (Site 4). Samples from Bolin Creek and Morgan Creek were collected in June 2012; tributary sites were sampled in April 2012. The 2012 sites were collected later in the year compared to the 2011 collections. There was better flow in 2012 and less filamentous algae at most sites.

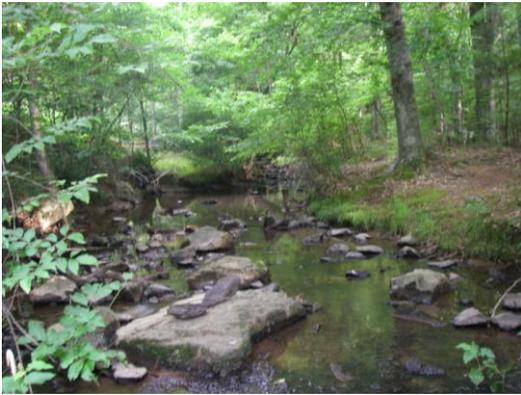
Bolin Creek Site 1, June 2012.

This part of Bolin Creek averaged about 4-5 meters wide, with a substrate mainly composed of gravel and rubble. Both the substrate composition and the width, however, were highly variable. There were no significant habitat problems in this section of Bolin Creek.

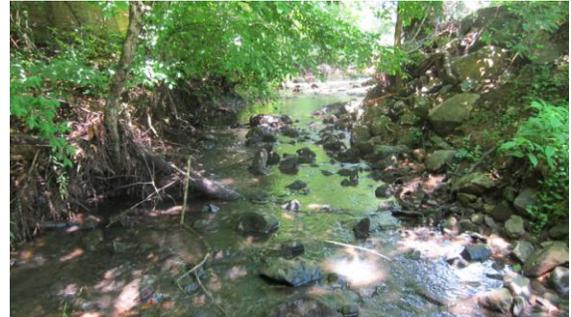
Bolin Creek Site 2, June 2012.

Bolin Creek 2. Site 2 is located downstream of the Winmore development at SR 1777. There is private residence on one side of the stream that lacks a buffer zone. Consequently, there is significant bank erosion on one side of the stream.

Habitat problems included fewer riffles, bank erosion, lack of a buffer on one side and a decrease in habitat diversity. The very abundant filamentous algae that was observed in 2011 was not seen in the June 2012 collections.

A beaver dam was observed slightly upstream of this site.

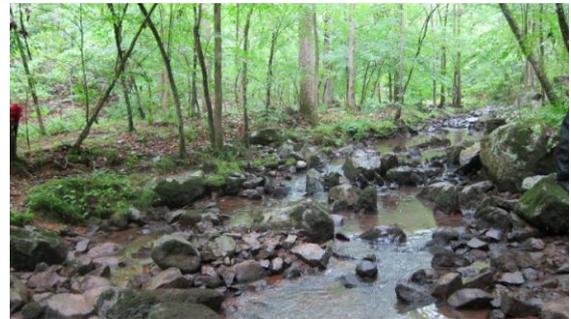
Bolin Creek Site 3, June 2012.

There are no significant habitat problems in this portion of the stream, but there was a lack of good bank habitat.

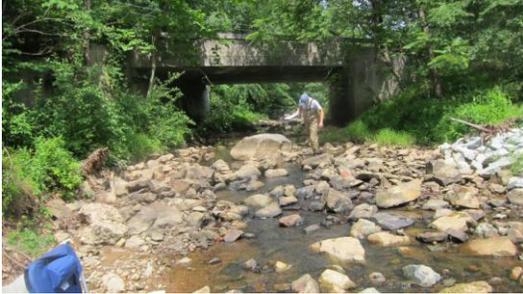
Bolin Creek Site 4, June 2012.

This portion of Bolin Creek is similar to the site on Estes Drive, having good rocky substrate. Attached filamentous algae was very abundant at the Village Drive site in March 2011, but was not a problem in 2012

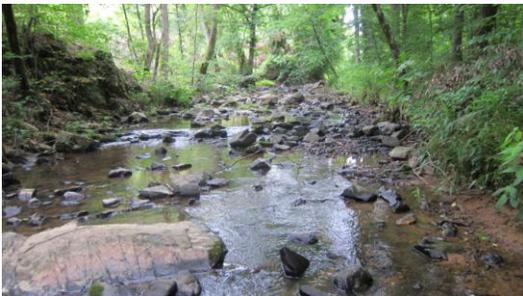
Morgan Creek, NC 54, June 2012.

This catchment has a largely rural character, with some minor impacts from nonpoint source runoff. Habitat quality, stream width and substrate composition are similar to Bolin Creek, but with less residential land use.
