*Existing  
Conditions  
Report*

TOWN OF CARRBORO, NC

**BOLIN CREEK  
GREENWAY**

*prepared by:*  
**Greenways Incorporated,**  
**EcoScience & PBS&J**  
February 2009

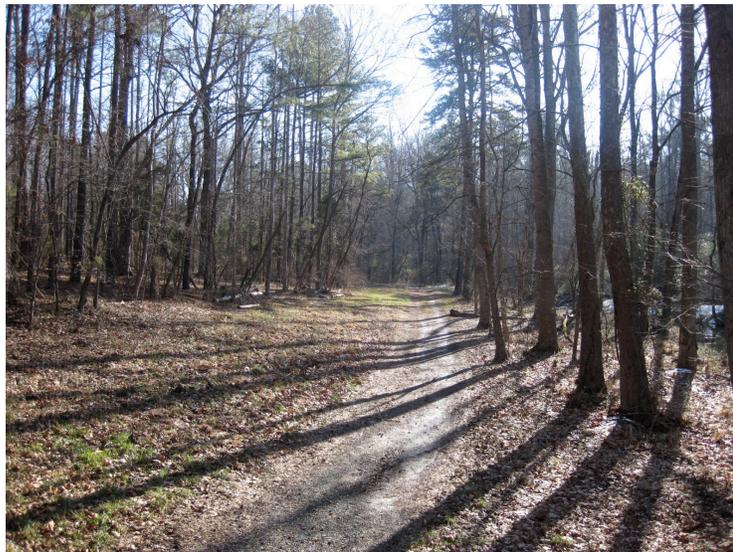
*Looking south down easement along Carolina North Forest property.*

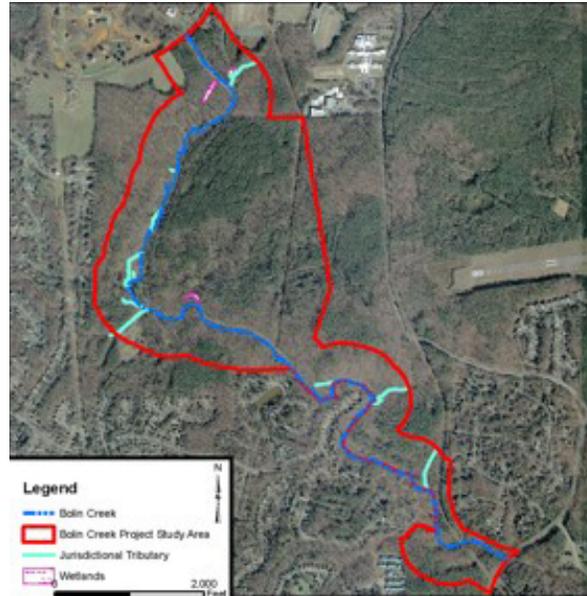
Section 404 Resources within the Bolin Creek PSA

A jurisdictional delineation was not performed as a part of this preliminary constraints evaluation. However, potential jurisdictional areas were documented during field investigations. Streams, wetlands, and waters of the U.S. were observed within the PSA.

- The PSA contains jurisdictional streams, wetlands, and other waters of the U.S. A jurisdictional delineation of these systems is recommended along the preferred design corridor for the greenway segments once those alignments have been identified.

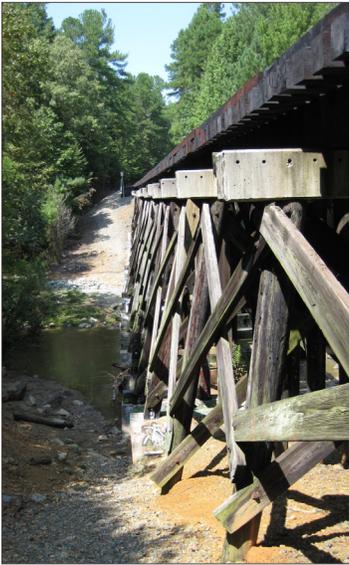
Railroad line at Estes Dr. Ext.

Railroad routes adjacent to or crossing a trail present a significant situation within trail development. The rights-of-way associated with rail lines are typically very wide and their owners fear the liability associated with public access. The proposed Bolin Creek trail will encounter the Norfolk Southern rail line, which parallels and then crosses over the southern portion of the corridor. Depending on final trail alignment, negotiations will need to be made with Norfolk Southern as to the degree of public access allowed within their right-of-way.

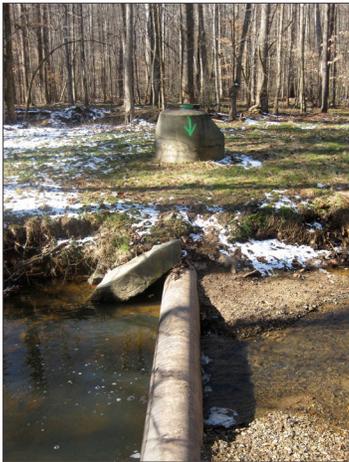
Typical sewer trunk line along Bolin Creek

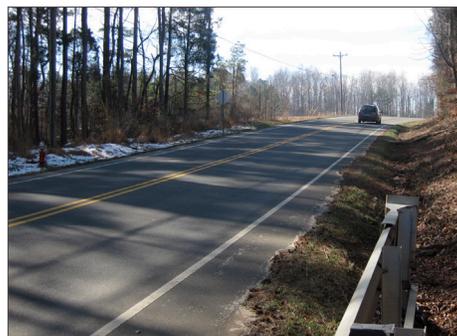
Homestead Rd. at grade.

- **Homestead Road** -High speeds (45 miles per hour), and two lanes of traffic make up this roadway which is heavily used to connects northern Carrboro to western Chapel Hill. Poor site lines at grade make a crossing unlikely. Below-grade conditions present feasibility for trail underpass with vertical clearance. North of Homestead Rd., topography and property constraints warrant further analysis depending on final trail alignment.

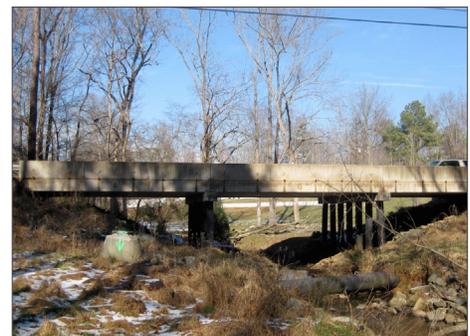
Bridge at Homestead Rd.

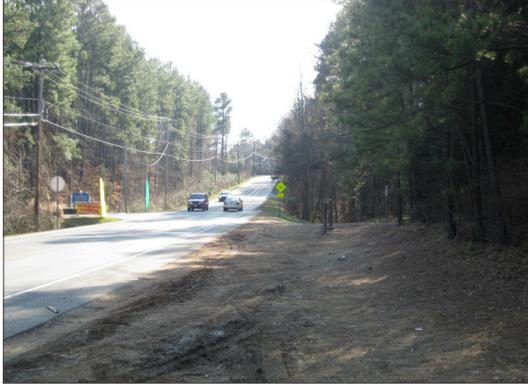
- *Estes Drive Extension* - A highly trafficked, north-south thoroughfare connecting Chapel Hill to Carrboro. Roadway crossing is approximately 30-feet above Bolin Creek with 3:1 slopes presenting a topographical challenge for at-grade crossing conditions. Poor site lines at north and south ends present dangerous at-grade crossing conditions.

*Estes Dr. at grade.*

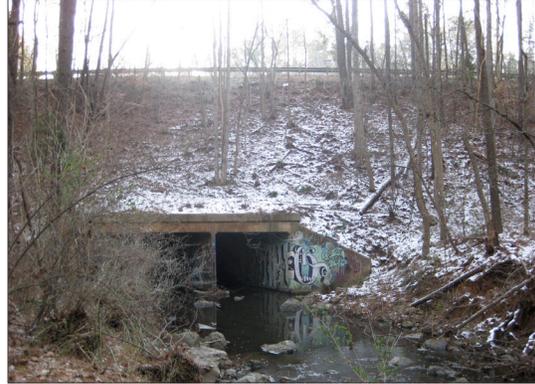
*The box culvert beneath Estes Dr. extension.*

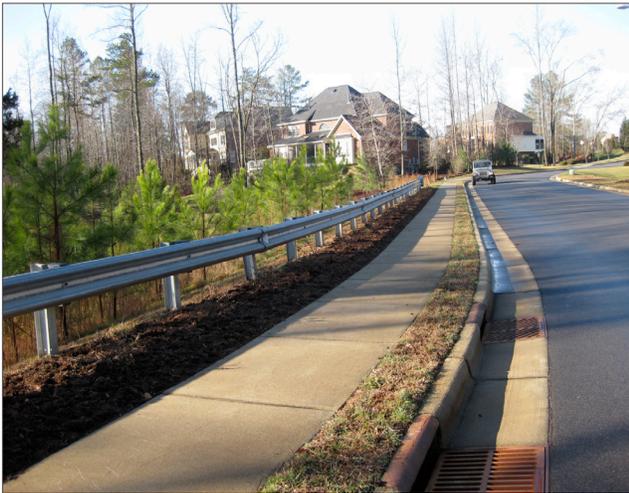
*Turtleback Crossing at grade.*

- *Turtleback Crossing* -A residential connector, this roadway is two lanes and has a speed limit of 25 miles per hour. At-grade crossings are more feasible at this location because site lines are open and topography surrounding the roadway crossing is less drastic.

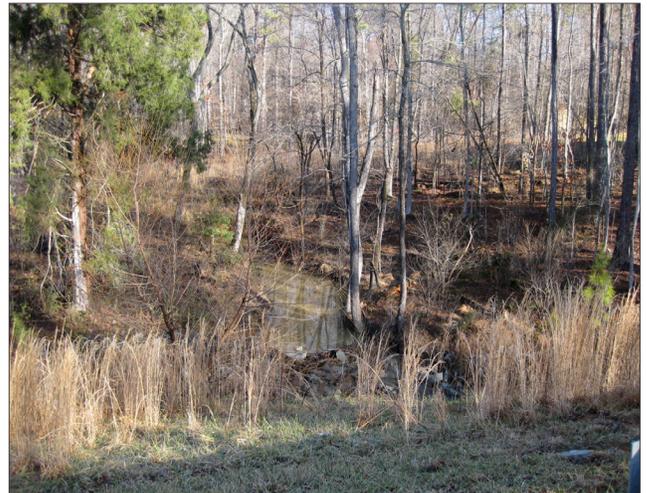
*Creek crossing conditions beneath Turtleback Crossing.*

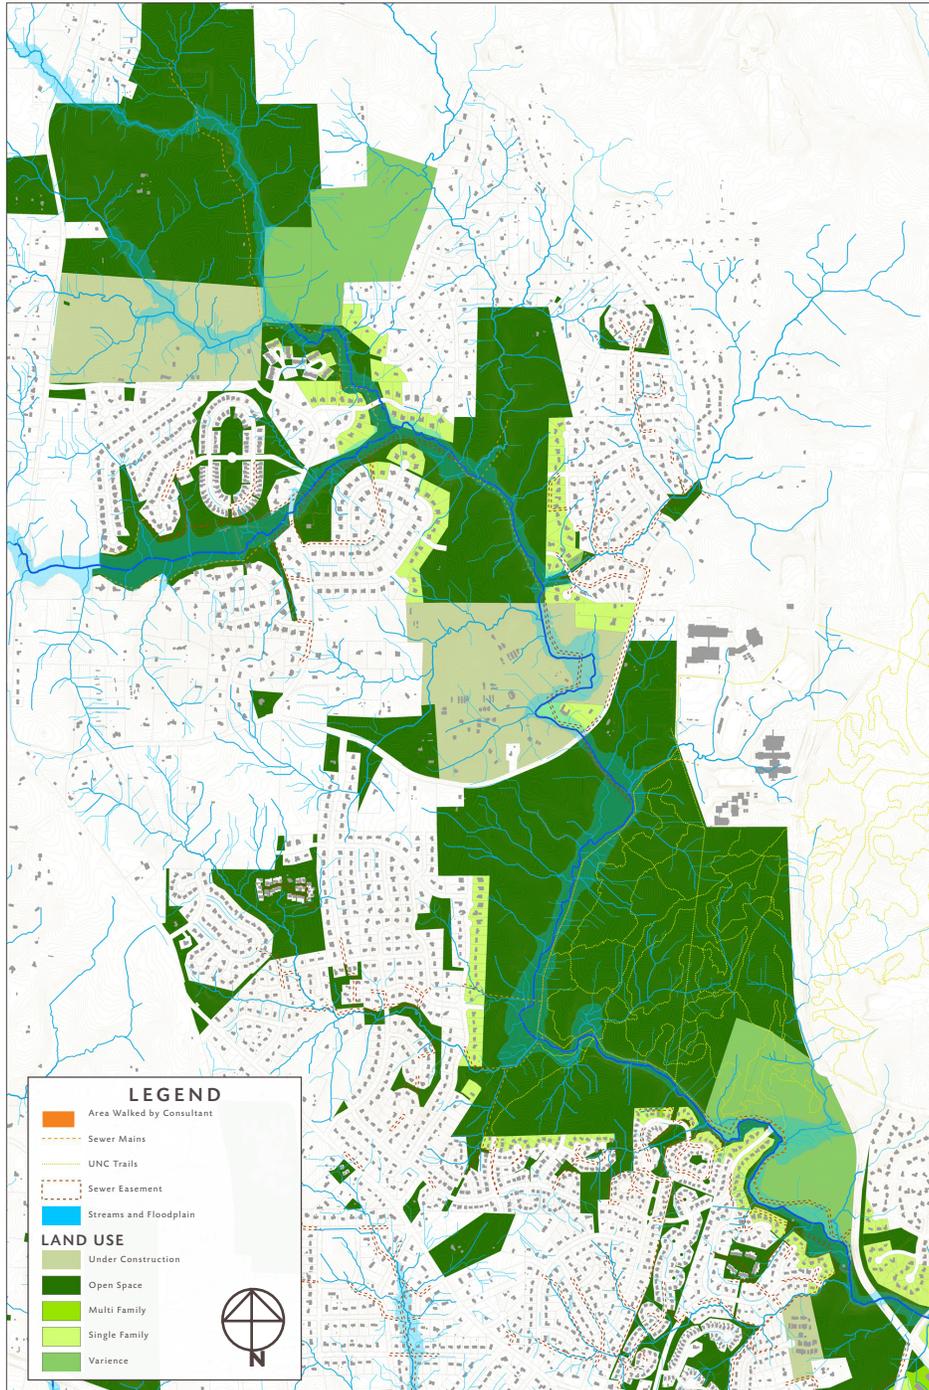
Residential land use makes up the majority of the study corridor. The corridor is adjacent to the following neighborhoods: Ironwoods, Bolin Forest, Spring Valley, Cates Farm, Claremont I, Winmore, Lake Hogan Farms, and Tallyho Circle. Because of neighborhood development, a sewer trunk line parallels Bolin Creek with connecting lines extending into adjacent neighborhoods. A vast majority of open space is found along the corridor and owned by the University of North Carolina-Chapel Hill (UNCCH), as well as undeveloped privately owned property near Bolin Creek.

Map showing various land use along study corridor.

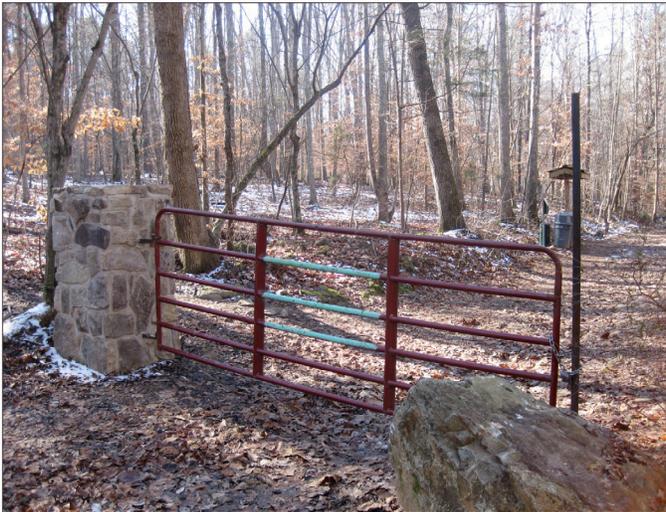
*Trail conditions behind Chapel Hill-Carrboro schools.*

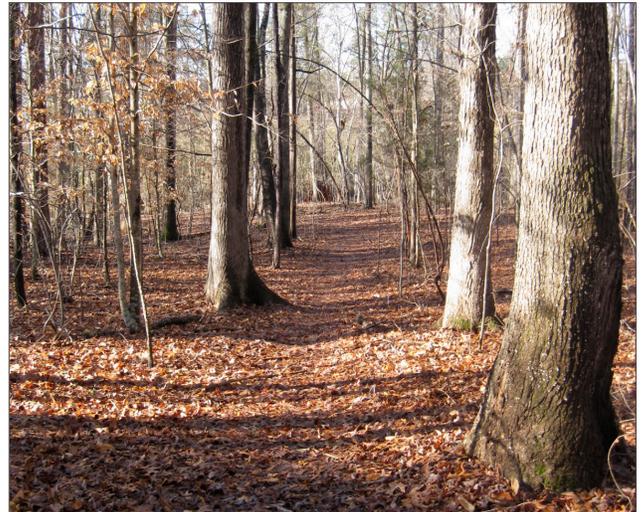
*Foot trails behind Tallyho Circle.*

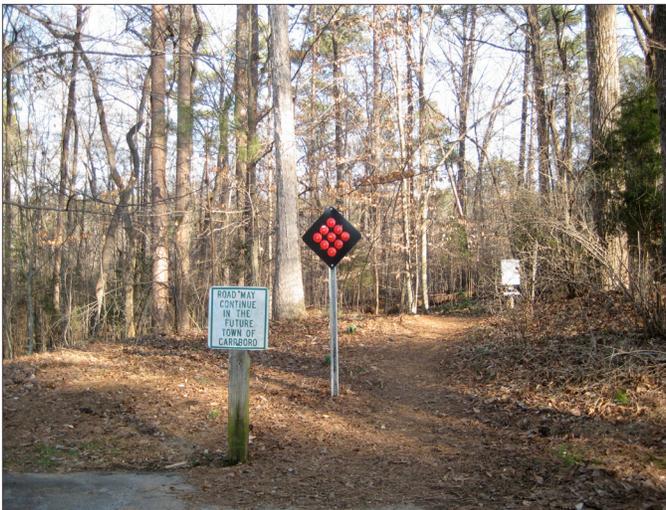
*Foot trails leading down to Bolin Creek from Pathway Drive.*

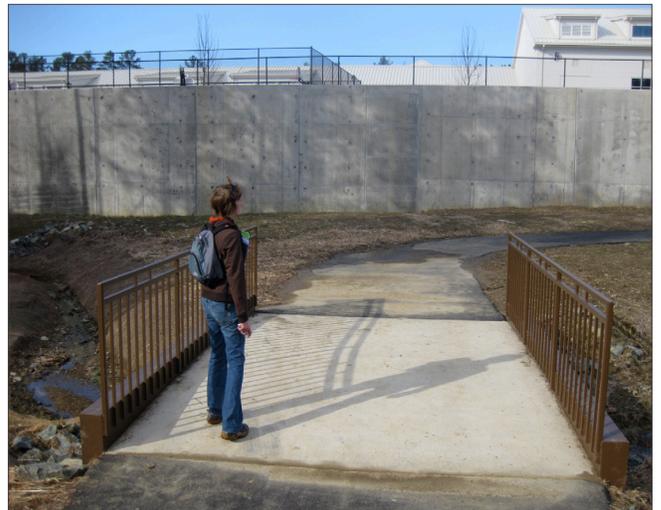
*Paved trail behind Morris Grove Elementary School.*

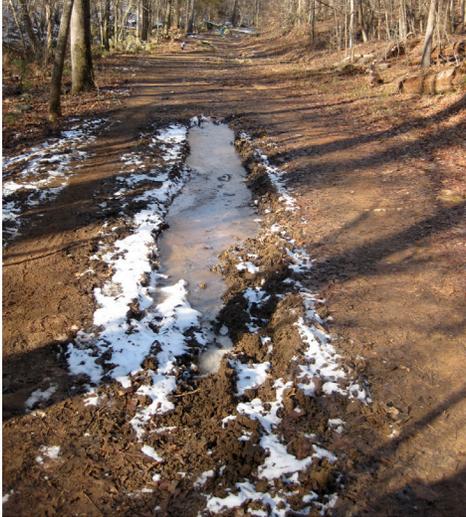
The wide, cleared surface of the sewer easement east of Bolin Creek provides innumerable opportunities for walking, mountain biking, running, jogging, dog walking and hiking. This high level of foot and bicycle traffic, combined with maintenance vehicle access, has caused the easement surface to become severely eroded and worn down. Deep ruts caused by bicycle and automobile tires create inundated conditions during storm events, thereby encouraging trail braiding along the path of travel. This sequence of events, in combination with

continuous high use, widens the area of disturbance over time. The agitated surface conditions created by foot and bike traffic lead to increased erosion and sedimentation along the corridor, which has the potential to affect water quality during storm events.

*Maintenance vehicles and overuse have contributed to erosion along the corridor.*

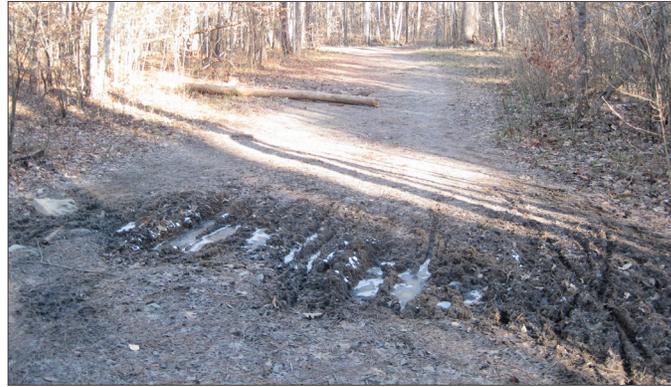
*Visible signs of overuse along Bolin Creek.*

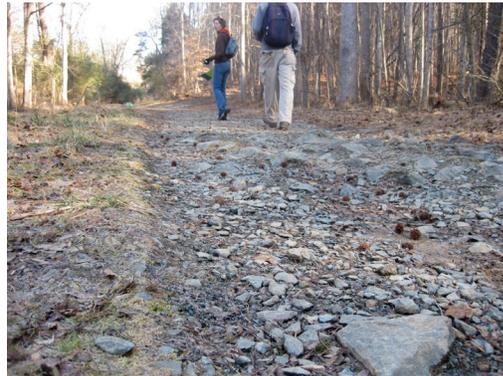
*Hardscape materials imported onsite have furthered erosion problems.*

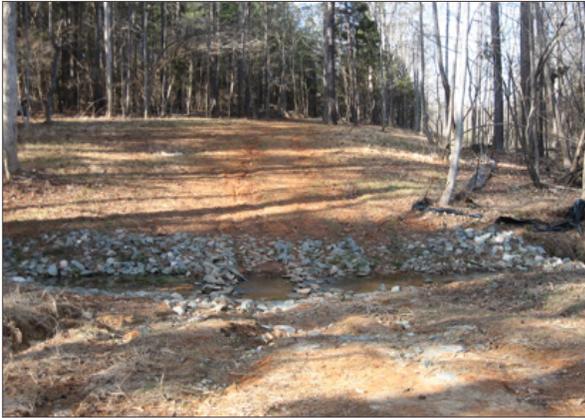
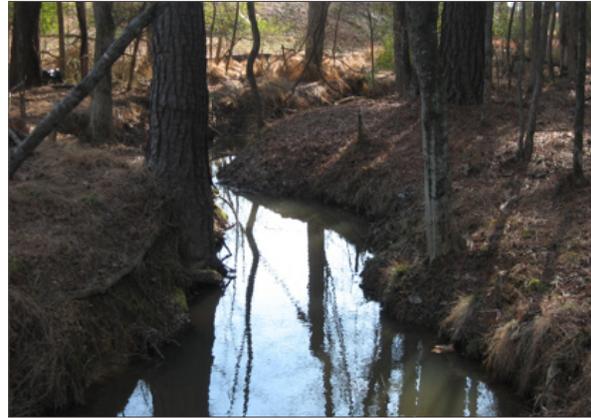
**Crossing #3**

This site is located on Buckhorn Branch (tributary to Jones Creek) and currently has rip-rap lined banks with additional rock in channel to facilitate the crossing of vehicles to gain access to a sanitary sewer easement. The channel's confluence with Jones Creek occurs immediately downstream. This site is presently located within the SFHA (~ 120 ft wide) and stream buffer, appears to be contained within a non-encroachment area (~ 40 ft), and experiences a 100-year flood discharge of approximately 450 cubic feet per second (cfs). PBS&J recommends the implementation of a low-flow, curbed concrete bridge connecting the stream banks of Buckhorn Branch, which would permit the greenway to utilize the existing sanitary sewer easement northward.

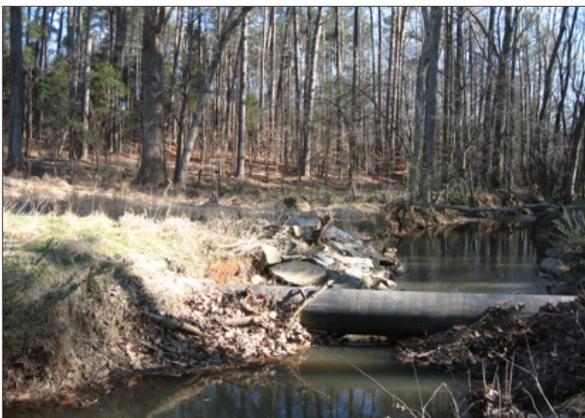
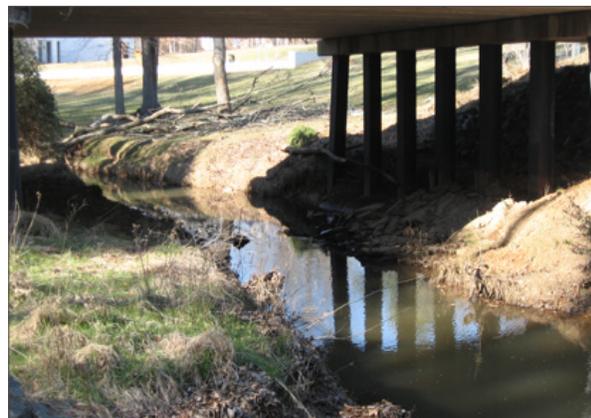
**Crossing #4**

This site is located on Bolin Creek at the Homestead Road Bridge with a large sanitary sewer ductile iron pipe (SSDIP) crossing immediately downstream of the bridge. This site is presently located within the SFHA (~ 130 ft wide) and stream buffer, is contained within a floodway (~ 60 ft), and experiences a 100-year flood discharge of approximately 2,790 cfs. PBS&J recommends utilizing the existing sanitary sewer easement along the west bank of Bolin Creek as the proposed greenway alignment and excavating the west bank underneath the bridge to establish an underpass for pedestrian access north and south of Homestead Road.

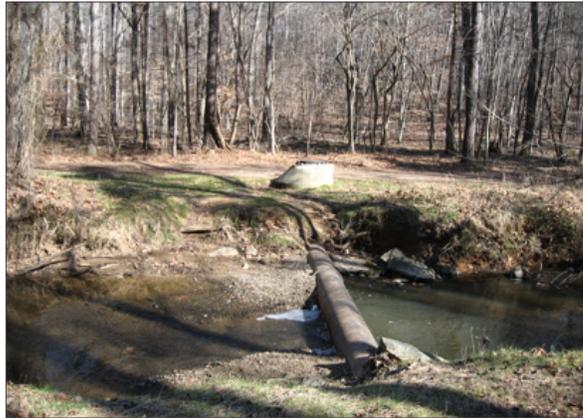
**Crossing #5**

This site is located on Bolin Creek at a SSDIP crossing and is presently located within the SFHA (~ 600 ft wide) and stream buffer, is contained within a floodway (~ 400 ft), and experiences a 100-year flood discharge of approximately 2,790 cfs. PBS&J recommends the implementation of an arched wooden bridge with guardrails that will connect the existing SS easement paralleling the east and west stream banks in such a way that will not hinder access to the SSDIP and its two associated manholes.

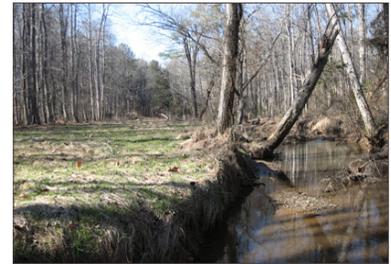
**Crossing #7**

This site is located on Bolin Creek and is presently located within the SFHA (~ 170 ft wide) and stream buffer, is contained within a floodway (~ 20 ft), and experiences a 100-year flood discharge of approximately 3,000 cfs. Fallen trees along stream banks and significant debris in channel at meander indicate possible beaver activity. An existing SS easement parallels the east bank. Given the wide channel, PBS&J recommends the implementation of an arched wooden bridge with guardrails.

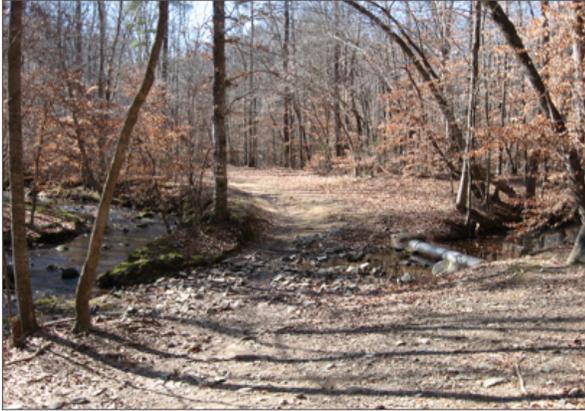
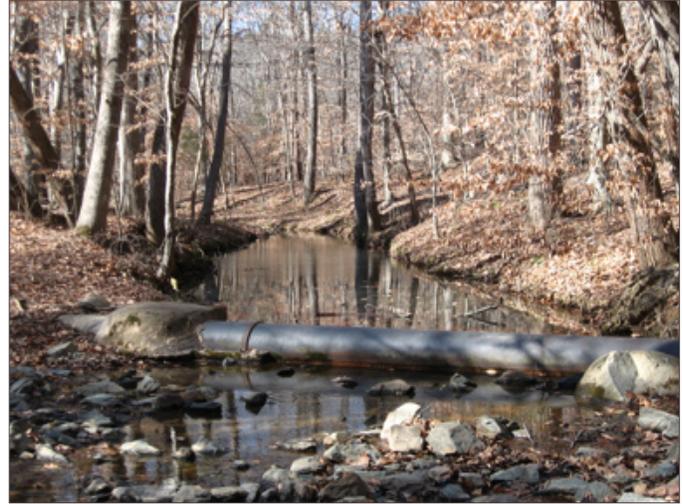
**Crossing #8**

This site is located at the confluence of Bolin Creek and a tributary near a SSDIP crossing. This site is presently located within the SFHA (~ 240 ft wide) and stream buffer, is contained within a floodway (~ 90 ft), and experiences a 100-year flood discharge of approximately 3,600 cfs. A three-foot wide wooden footbridge currently provides access from the playground (west bank) to the existing SS easement on the east side of Bolin Creek. PBS&J recommends the implementation of a low-flow, curbed concrete bridge over the tributary immediately downstream of the SSDIP crossing and an arched wooden bridge with guardrails over Bolin Creek in vicinity of the existing footbridge to provide access from the playground.

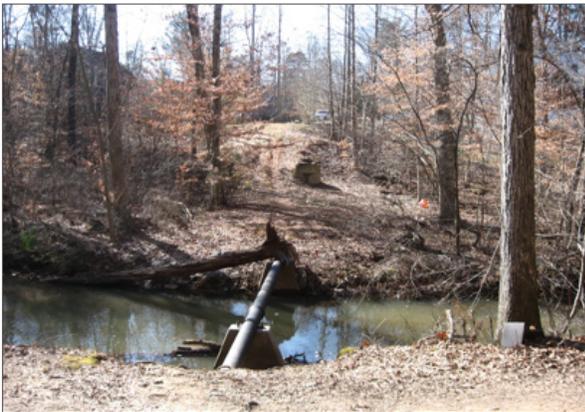
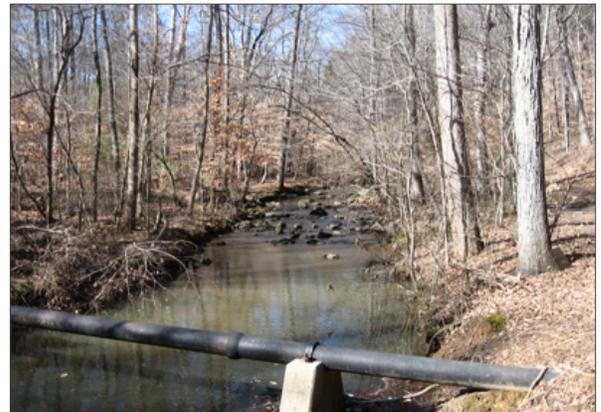
**Crossing #9**

This site is located on Bolin Creek at a SSDIP crossing. This site is presently located within the SFHA (~ 140 ft wide) and stream buffer, is contained within a floodway (~ 110 ft), and experiences a 100-year flood discharge of approximately 3,600 cfs. One SS easement parallels the east bank, while another is perpendicular to the west bank. PBS&J recommends the implementation of an arched wooden bridge with guardrails over or adjacent to the SSDIP crossing.

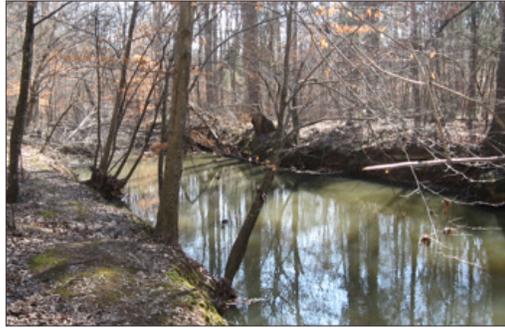
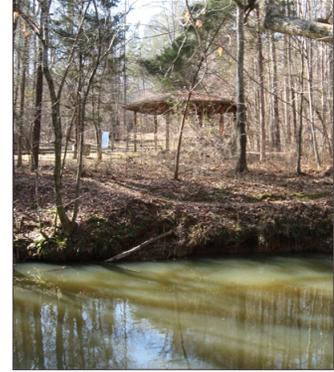
**Crossing #10**

This site is located on Bolin Creek and is presently located within the SFHA (~ 100 ft wide) and stream buffer, is contained within a floodway (~ 45 ft), and experiences a 100-year flood discharge of approximately 3,800 cfs. A playground and pavilion exists in the floodplain on the west side of the creek. An existing SS easement parallels the east bank. PBS&J recommends the implementation of an arched wooden bridge with guardrails where the channel is most narrow immediately below the meander.

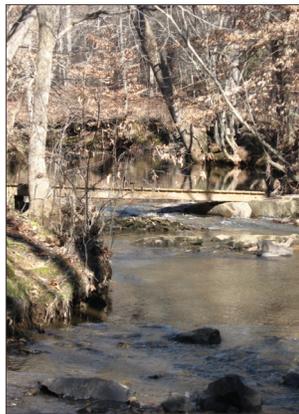
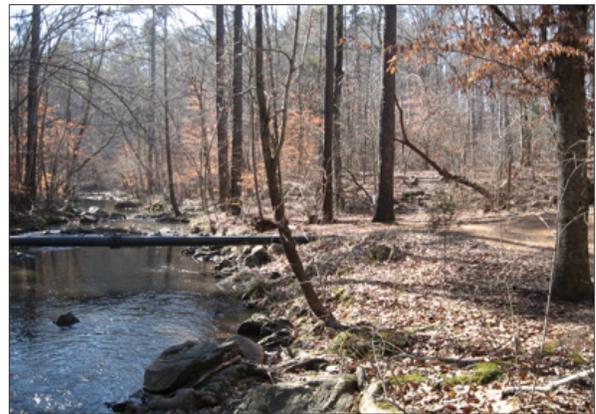
**Crossing #11**

This site is located on Bolin Creek at a SSDIP crossing. This site is presently located within the SFHA (~ 55 ft wide) and stream buffer, contained within a floodway (~ 45 ft) and experiences a 100-year flood discharge of approximately 4,100 cfs. A three-foot wide wooden footbridge provides access between the playground and walking trail on the west to the existing SS easement on the east side of the creek. PBS&J recommends replacing the existing footbridge with an arched wooden bridge with guardrails.

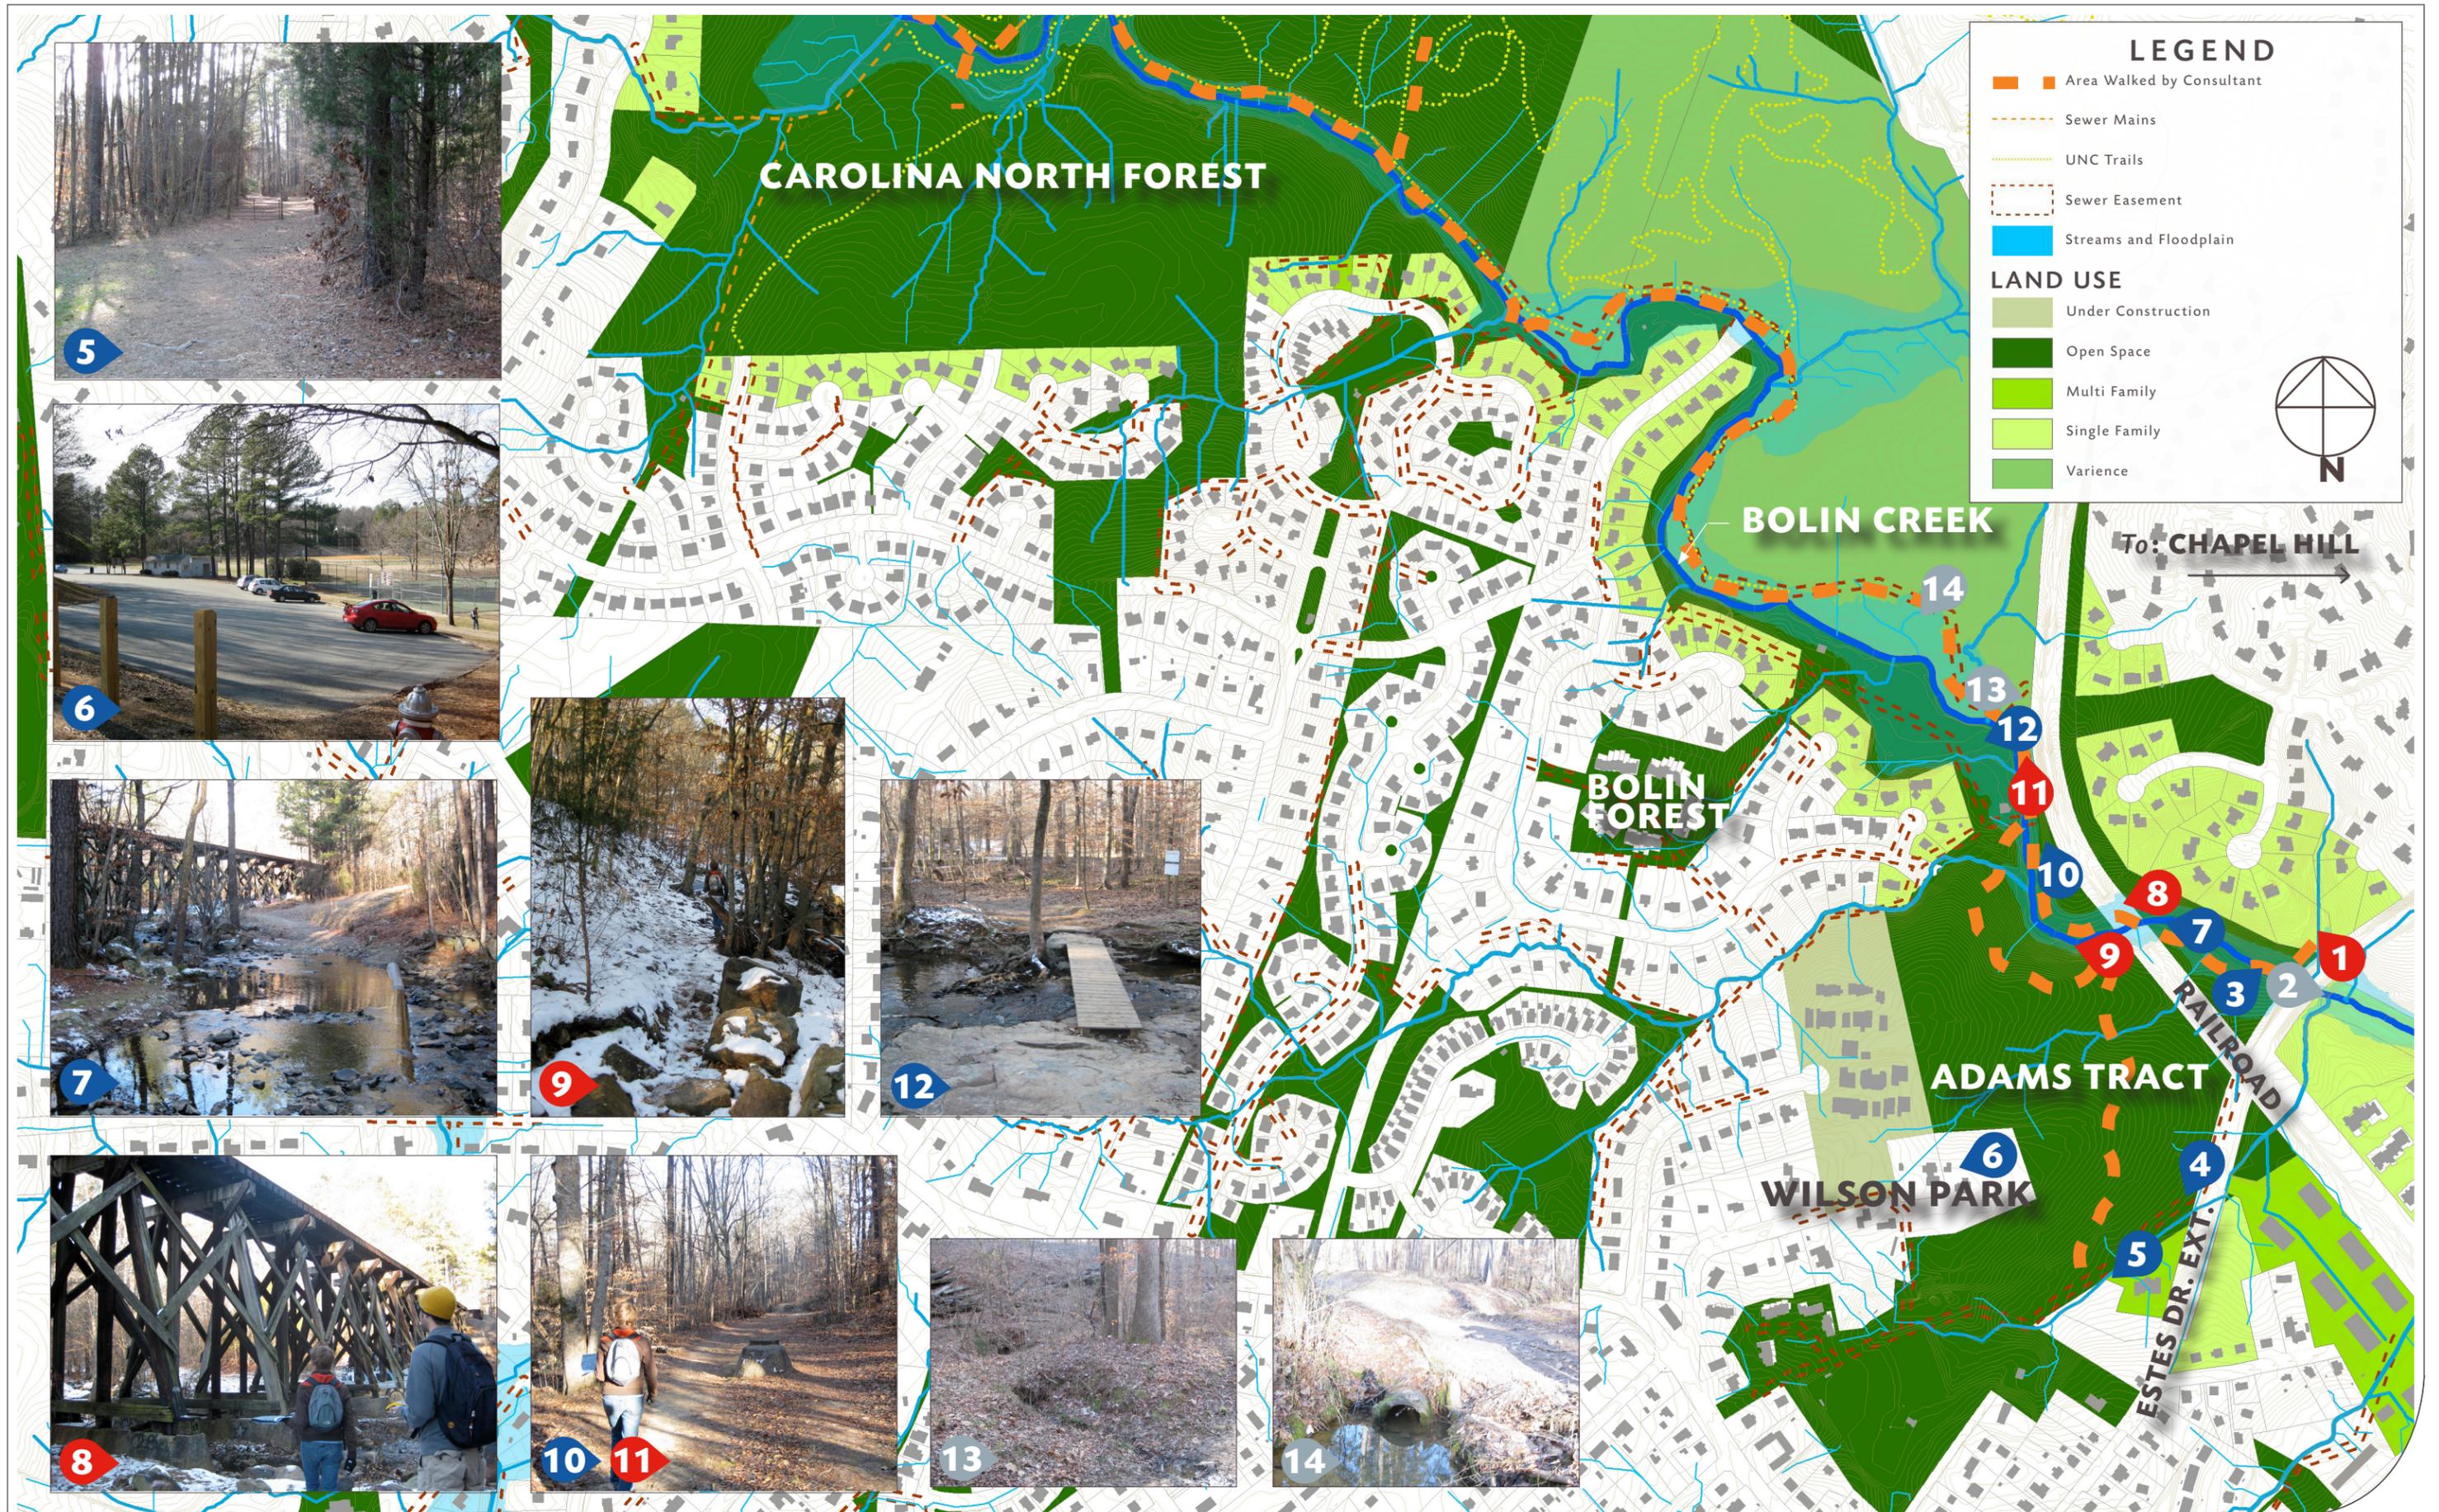
## Existing Conditions: Estes Drive Extension to Carolina North Forest Boundary

- 1 Constraint:** The finished grade of Estes Drive extension is approximately 25 feet above Bolin Creek. Steep 3:1 slopes from the roadway to the creek will make both an at-grade crossing or a trail underpass a cost, safety and permit constraint.

- 2 Opportunity & Constraint:** Box culvert roof beneath Estes Dr. could lend itself to a benched trail condition with a hand rail; however, some tree removal, permitting and construction costs will be the exchange.

- 3 Opportunity:** Sewer easement along Estes Dr. extension provides a cleared, open corridor ideal for trail conditions.
- 4 Opportunity:** This unofficial parking area for the Adams Tract trails is highly eroded from vehicular use; trail enhancement could clean up this area's erosion issues.

- 5 Opportunity:** Sewer easement has the potential to connect Wilson Park and use along Estes Dr. extension via the proposed Bolin Creek trail.
- 6 Opportunity:** Wilson Park's existing facilities, which include ball fields, picnic areas, tennis courts, tot lots, and parking/restrooms are ideal for trail head conditions for the proposed trail.

- 7 Opportunity:** Rocky shoals of southern Bolin Creek are ideal low water bridge crossings, which are a low impact solution for crossing conditions.
- 8 Constraint:** The Norfolk Southern railroad crosses Bolin Creek at the southern portion of the corridor which presents a right-of-way constraint.

- 9 Constraint:** Steep topography and rocky creek conditions limit trail development on the south side of Bolin Creek.
- 10 Opportunity:** Easement on north side of Bolin Creek is much more accessible and will require minimal disturbance for trail preparation.

- 12 Opportunity:** Ladder bridge that extends to Bolin Forest HOA playground is feasible condition for bridge crossing. A bridge would provide access to nearby residents. Large boulder and low stream banks provide opportunity for a low water bridge.

- 14 Opportunity & Constraint:** Exposed run-down pipes at the second major tributary crossing will need improvement to support a paved surface trail, which will be a cost and permit constraint. Opportunity exists to improve the drainage facility as well as beautify the crossing.

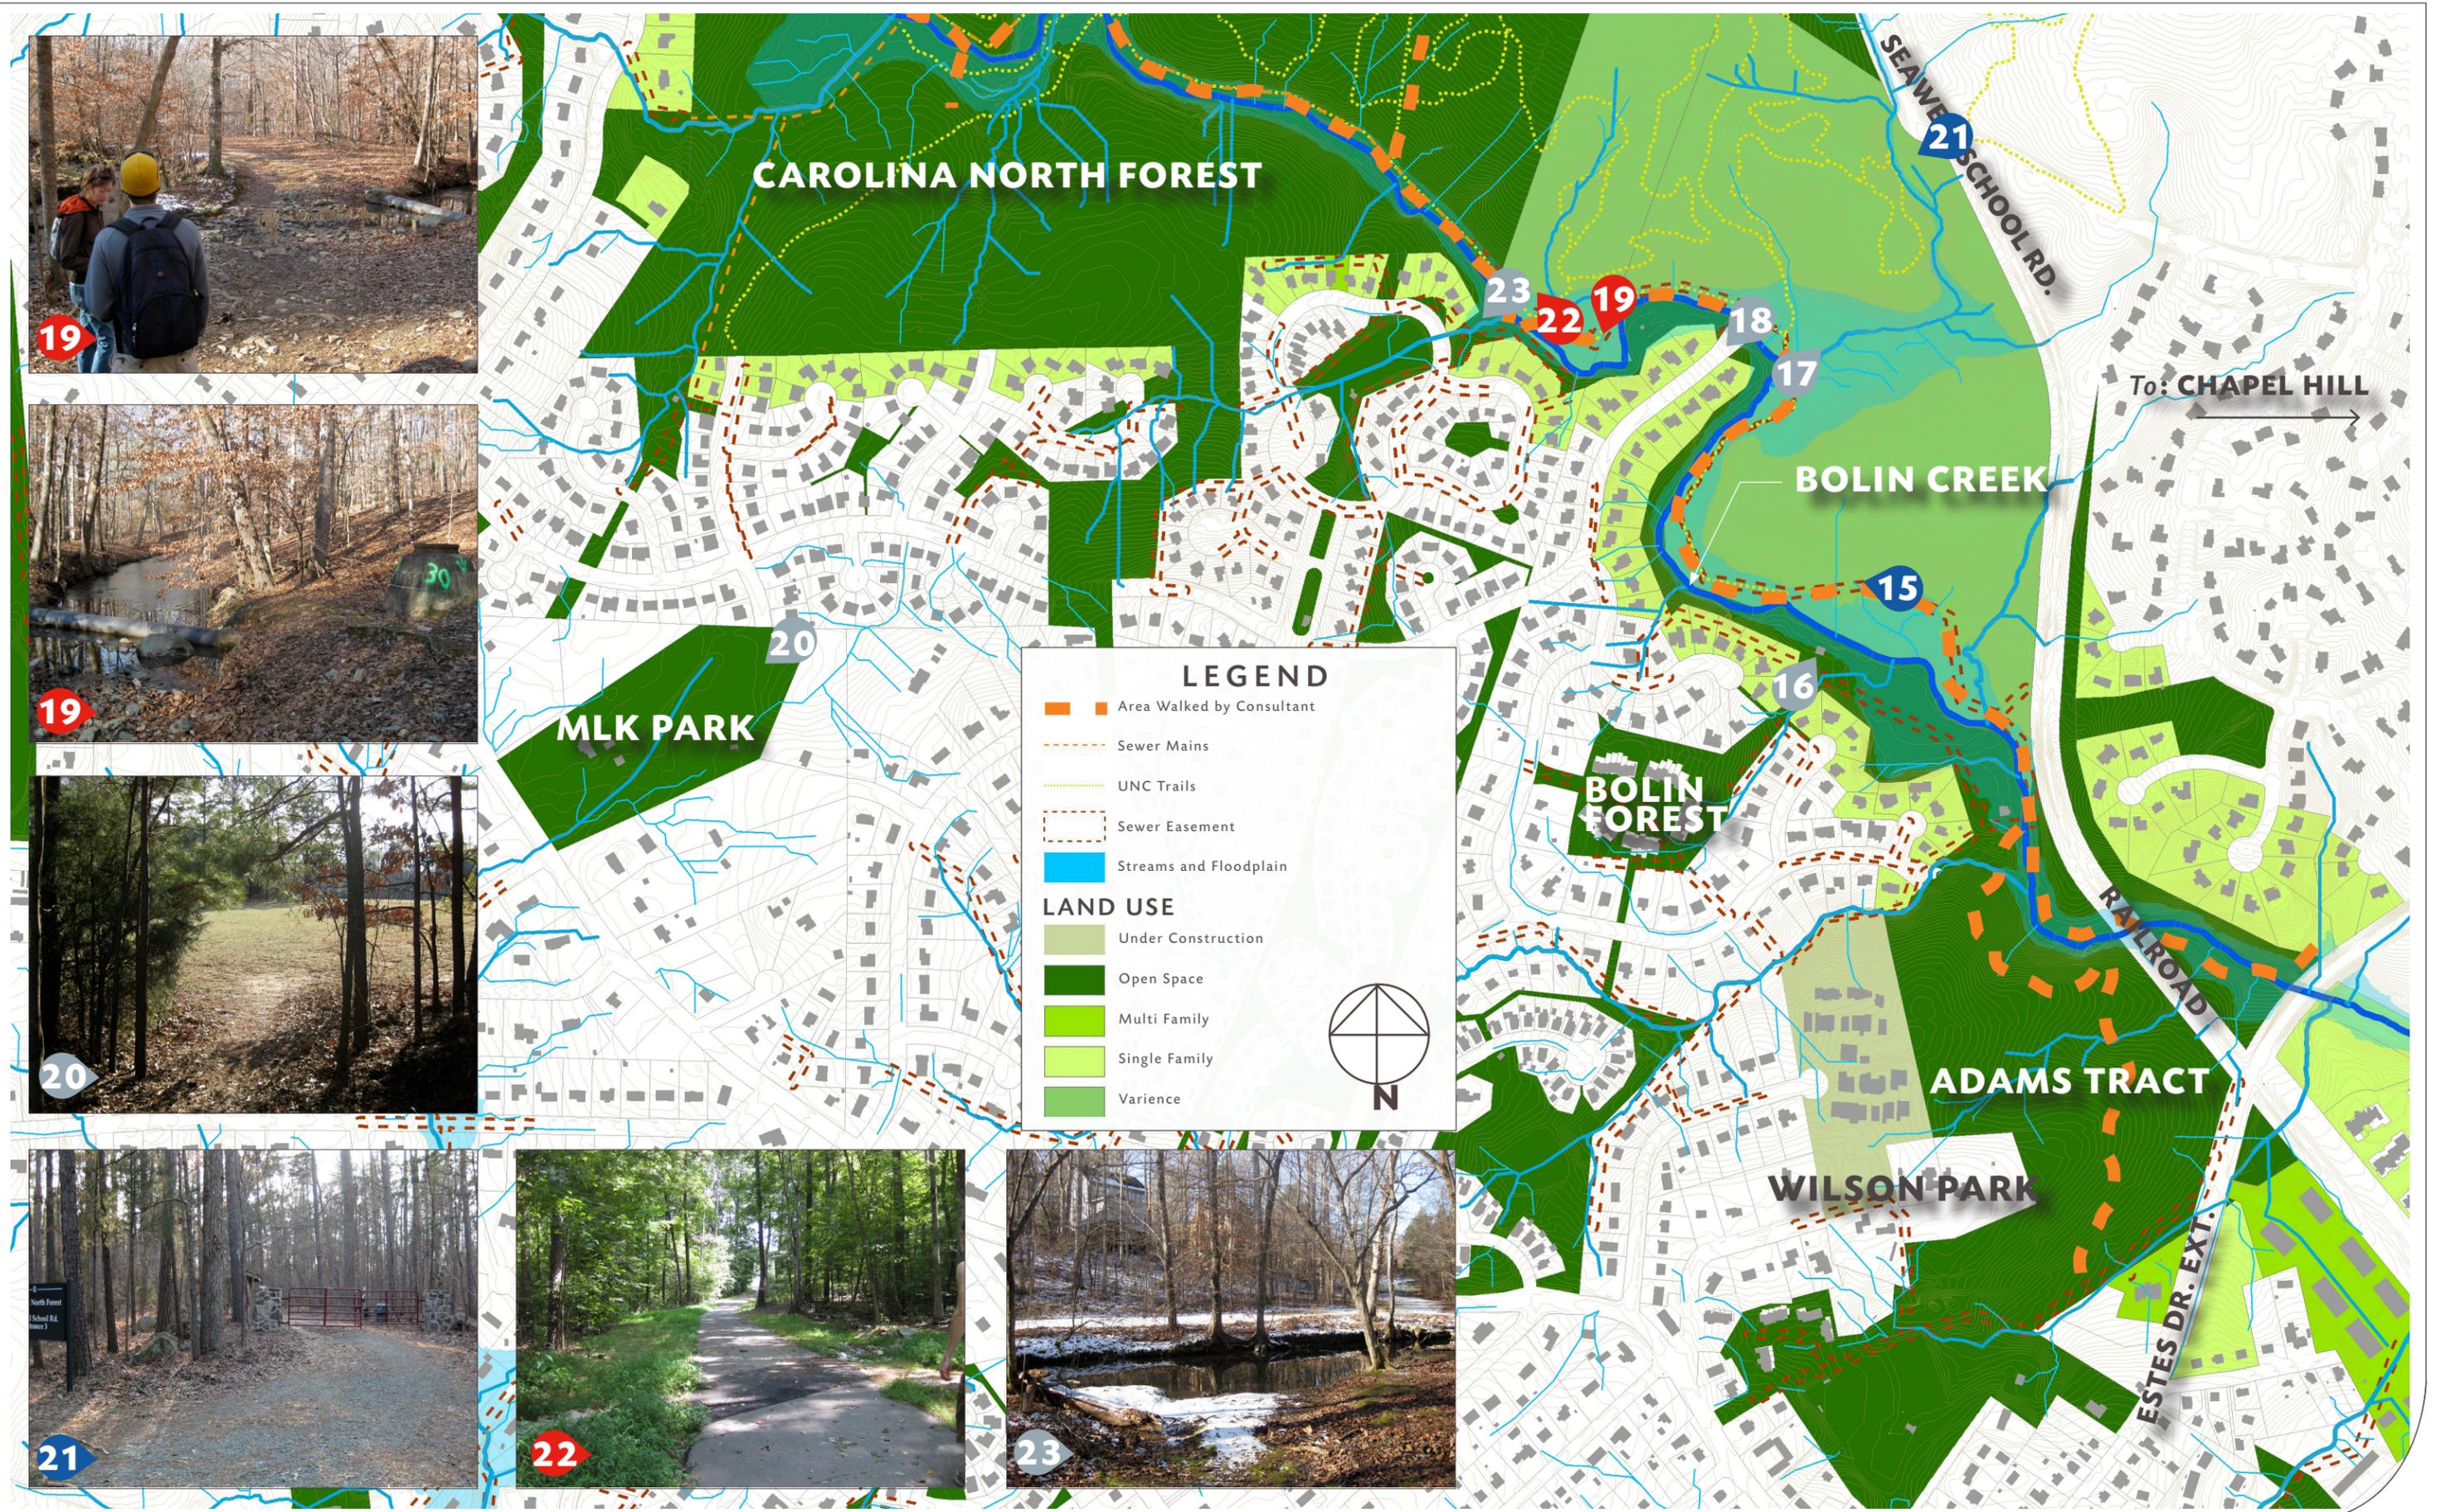
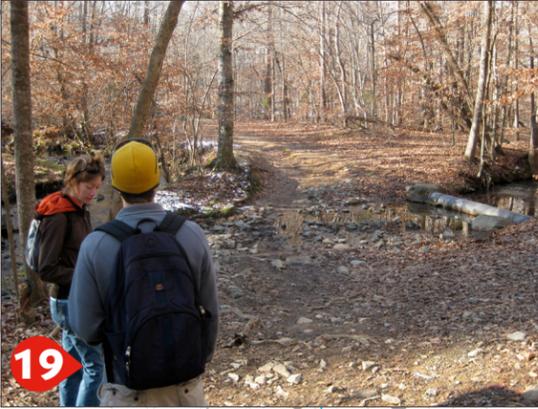
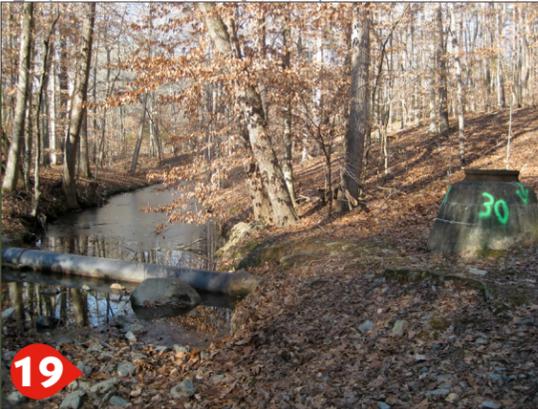
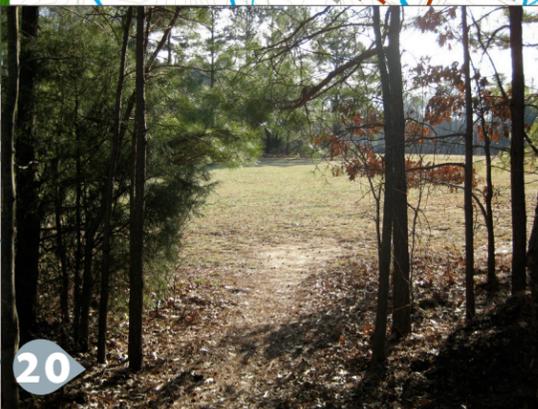
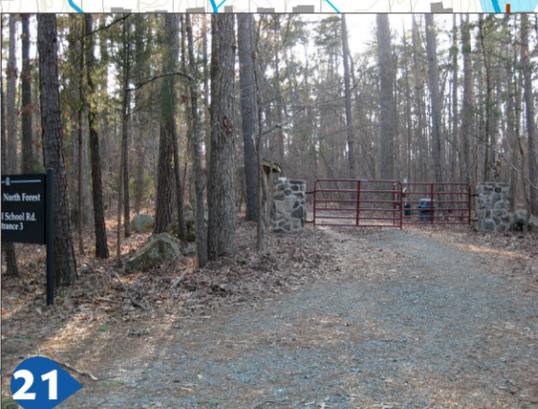
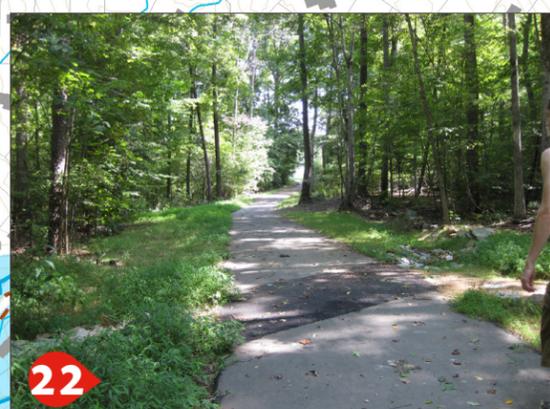
## Existing Conditions: Estes Drive Extension to Carolina North Forest Boundary

- 15 Opportunity:** Signs of overuse have severely eroded the creek corridor; however, providing a paved, delineated trail surface to users offers an environmental opportunity to limit trail braiding and discontinue erosion.

- 17 Opportunity & Constraint:** At the third major tributary crossing, the soil has been almost entirely washed away creating the need for a bridge condition which will be a cost constraint. Efforts to improve this area with a crossing will beautify the corridor, improve water quality by preventing more sediment to enter the stream at this location, and provide a safe crossing for all user groups.

- 18 Opportunity & Constraint:** This easement connects up to Pathway Drive, a major roadway in Bolin Forest and Cates Farm neighborhoods. Although conditions would permit a possible small-scale trailhead, topography is a constraint and a larger bridge would need to span the creek.

- 21 Opportunity:** Existing trail head features off of Seawell School Road encourage trail use and provide opportunity for network tie-in.
- 22 Constraint:** Existing rip rap that crosses corridor tributary will require a bridge to sustain foot and bicycle traffic, presenting permit and cost constraints.

- 23 Opportunity & Constraint:** Across the creek on the south side is another stretch of Bolin Forest HOA property that is flat, open and appropriate for trail development. A large creek crossing and land owner consent present constraints.
