*Existing  
Conditions  
Report*

TOWN OF CARRBORO, NC

**BOLIN CREEK  
GREENWAY**

*prepared by:*  
**Greenways Incorporated,**  
**EcoScience & PBS&J**  
February 2009

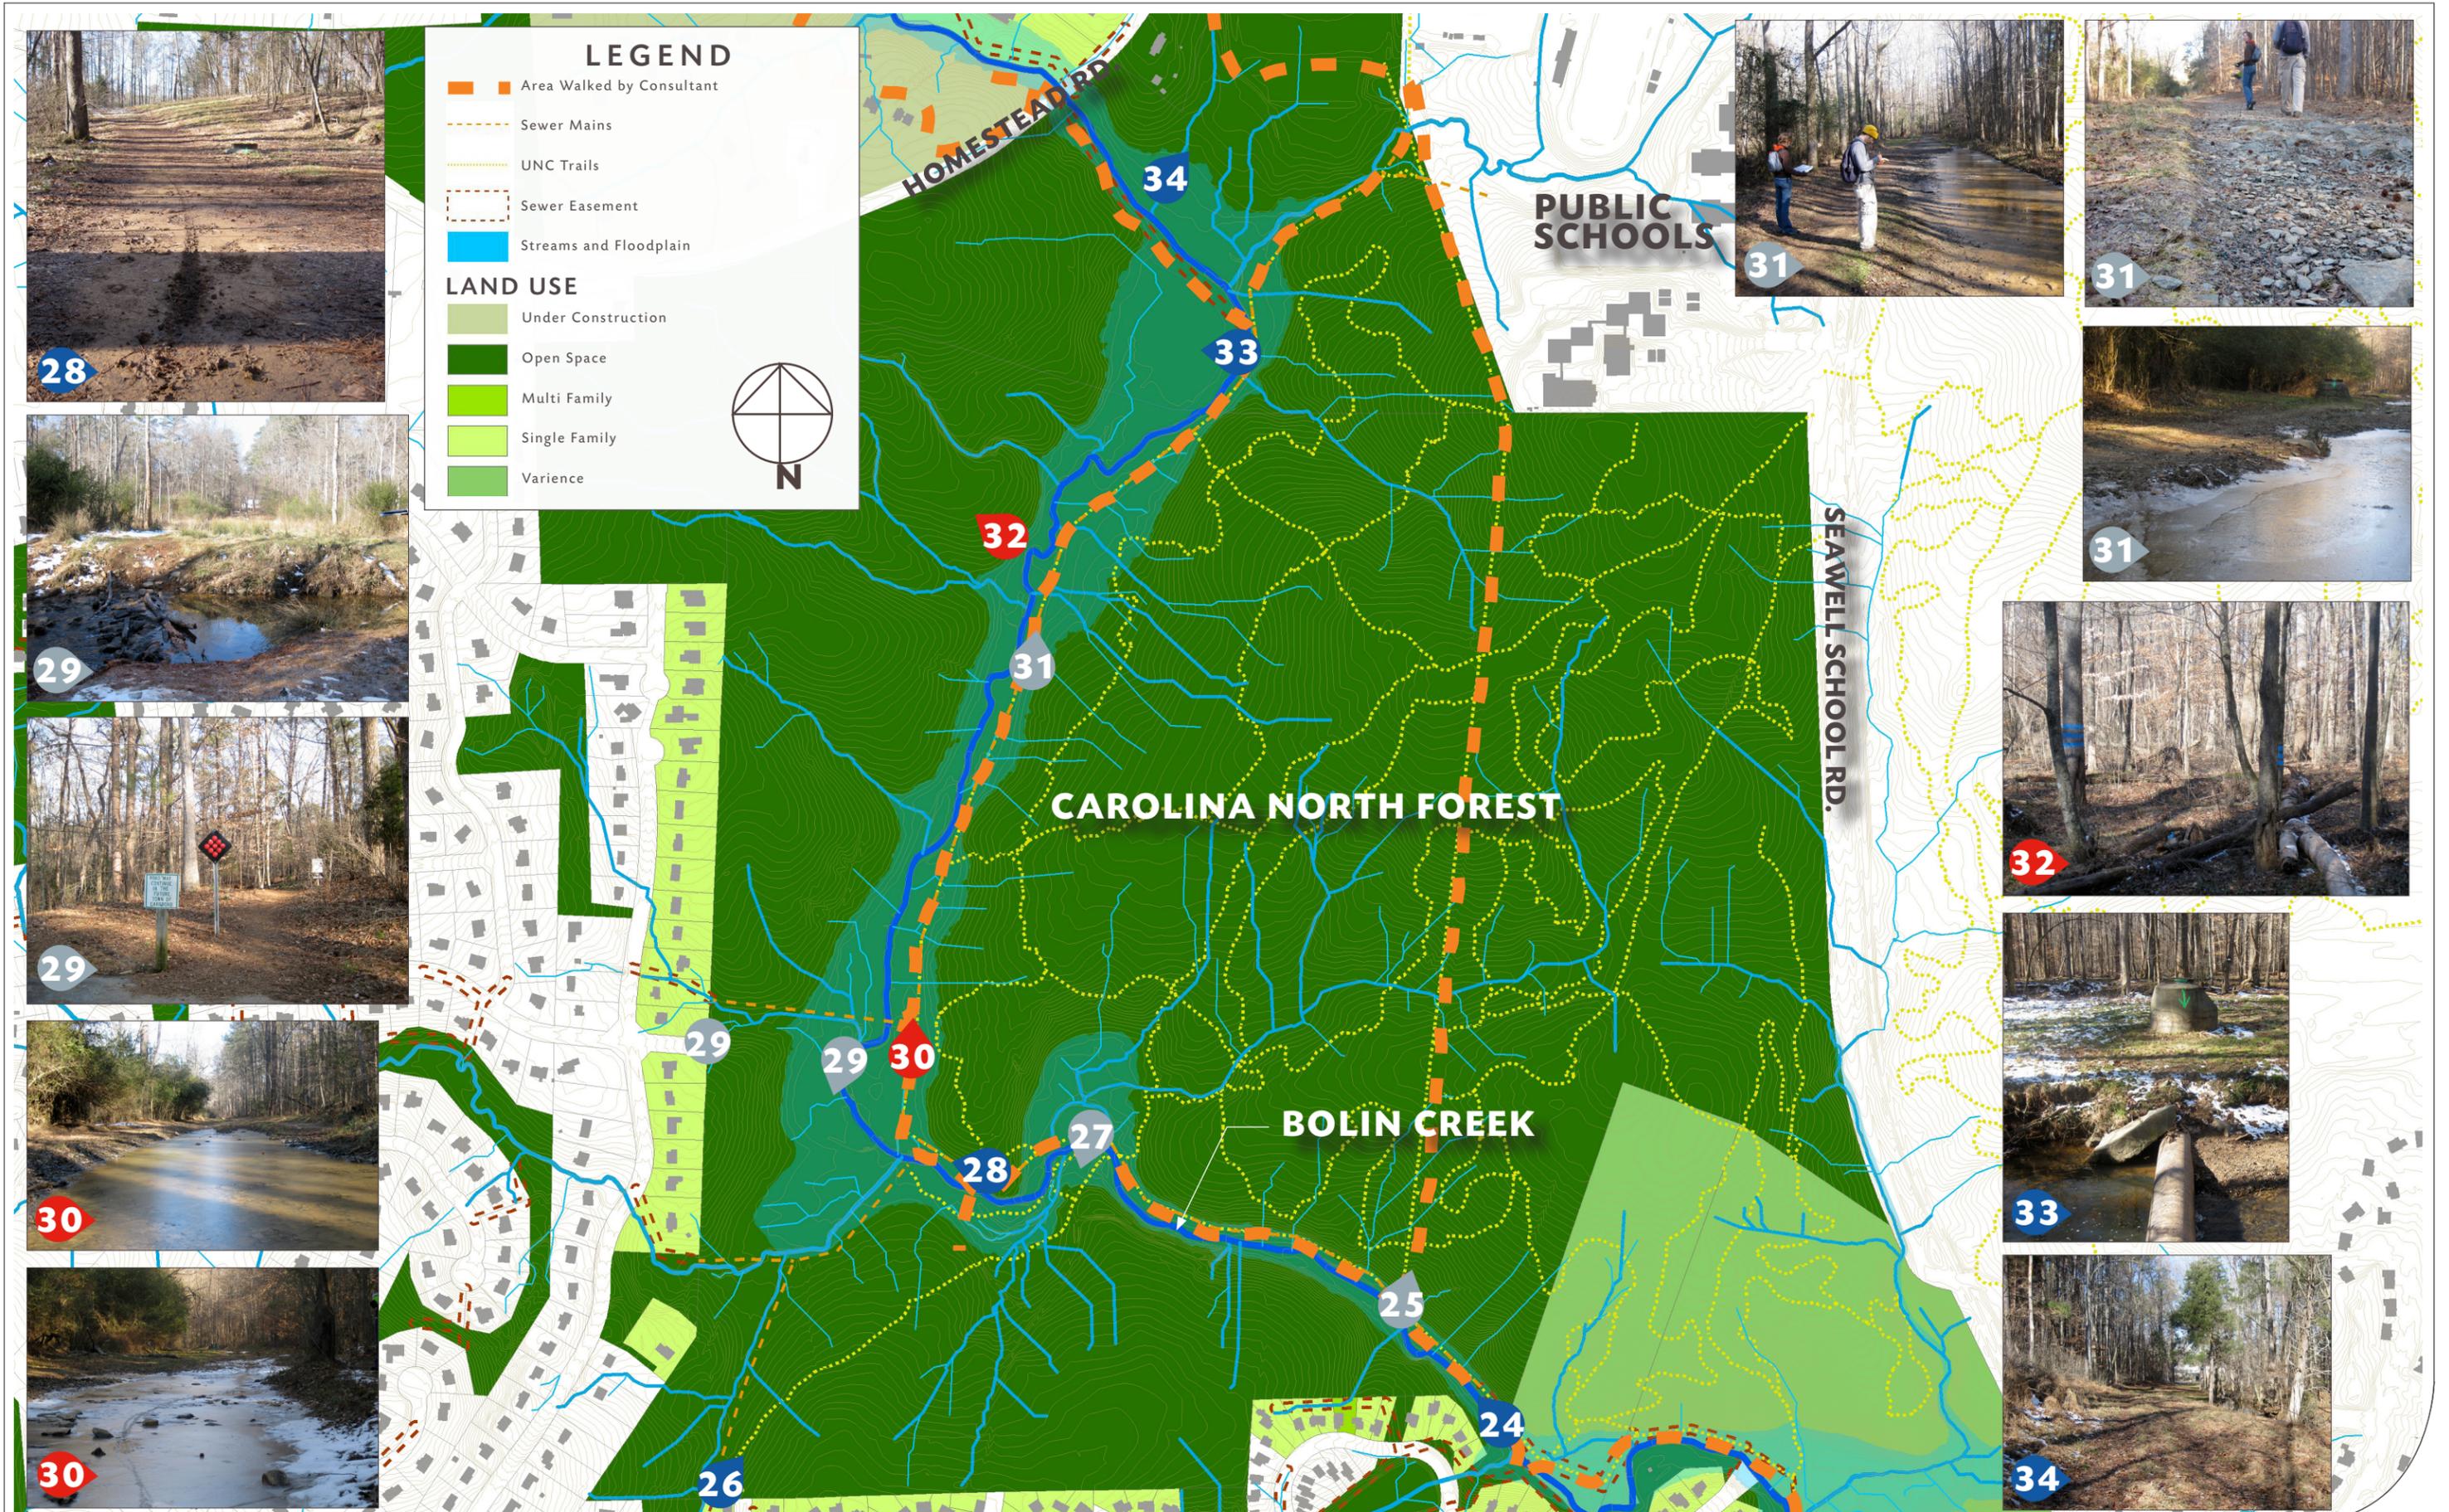
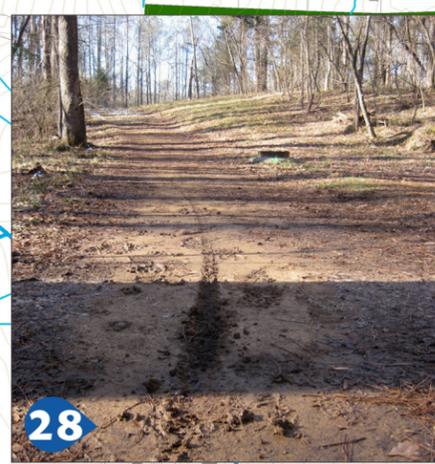
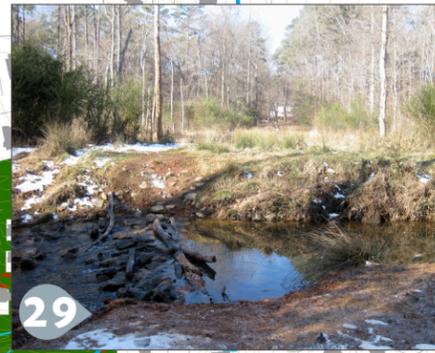
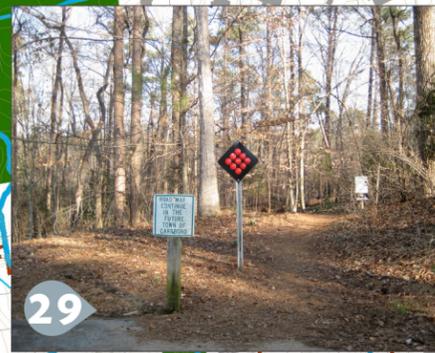
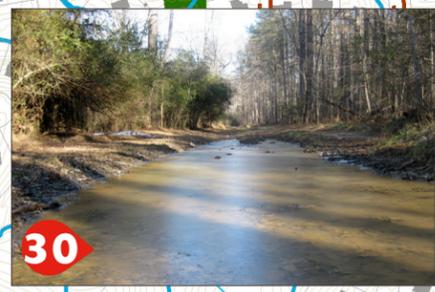
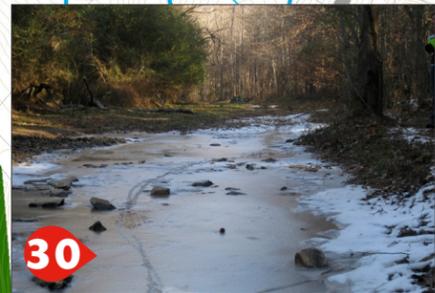
## Existing Conditions: Carolina North Forest Boundary - Creek Corridor

- 24 Opportunity:** The Carolina North Forest is an excellent opportunity for open space and recreation that supports trail development, offering an experience for all user groups including on-and off-road bicycles, children, and people with accessibility challenges.

- 25 Opportunity & Constraint:** The existing power easement is a popular recreational route for mountain bikers, runners, dogwalkers and hikers and has the potential to connect to the high school, middle and elementary schools; however erosion at the base of the easement indicate overuse and poor drainage conditions which will require possible alternate trail surfacing.

- 30 Constraint:** Parallel tributary along the corridor presents inundated conditions which will require raised boardwalk or alternative trail surfacing, constraining costs.

- 31 Opportunity & Constraint:** Standing water, crusher run laid by an outside source, and overuse have severely degraded this portion of the corridor. Visible signs of trail furrows and trail braiding continue to widen the corridor, further impacting the usable surface. With appropriate trail surfacing and vegetative restoration, the opportunity exists to mitigate the erosion problems, improve wildlife habitat and enhance the trail user experience.

- 32 Constraint:** Along the west side of Bolin Creek, stands of hardwood are present. If trail alignment is to occur in this area, tree removal will be required, presenting an environmental constraint.

- 33 Opportunity:** Low water bridge opportunity exists at this location, which could tie future neighborhood development into trail.
- 34 Opportunity:** Relatively flat conditions on the east side of Bolin Creek near Homestead Rd. create potential for sustainable trail development; hardwood trees dot the landscape offering a pleasant experience.

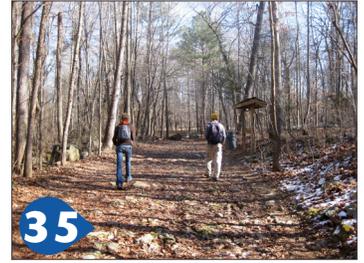
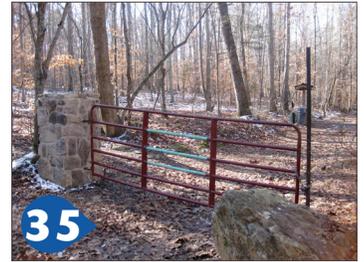
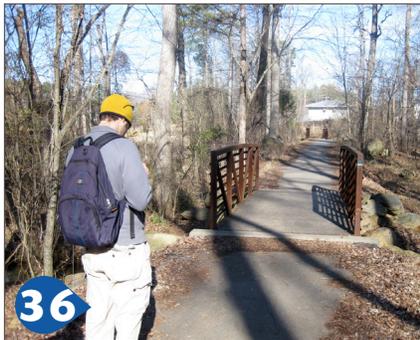
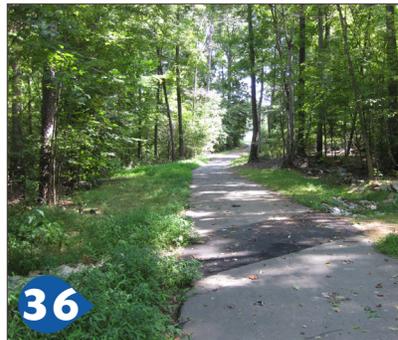
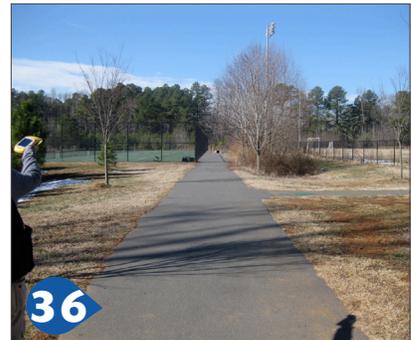
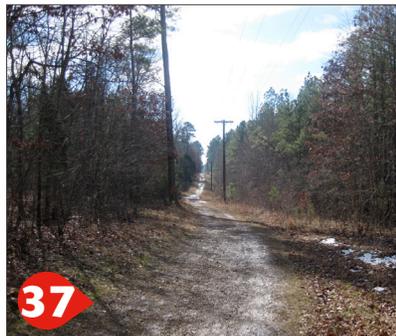
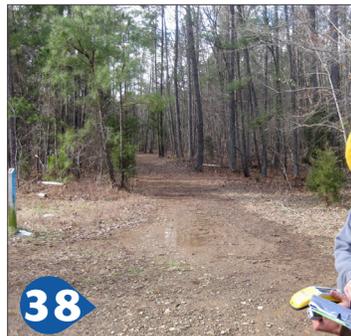
- 35 Opportunity:** Existing easement bends to the west to a kiosk and provides an upland route which connects ball fields and schools.
- 36 Opportunity:** Existing pedestrian trails have been installed as well as an outdoor classroom, indicating the high use of this area. Greenway development could improve these conditions, offering an alternative transportation for children attending school at this location.

- 37 Constraint:** Views down the power easement include transmission poles and straight-line conditions; compared to the creekside trail this alignment is less experiential.

- 39 Constraint:** Cross cut slopes, overuse, steep conditions and drainage problems have created severe erosion concerns along the power easement corridor.

- 40 Constraint:** User conflict along this area could be a potential constraint if trail is developed in upland corridor. Existing mountain biking trail users may not favor this interruption.

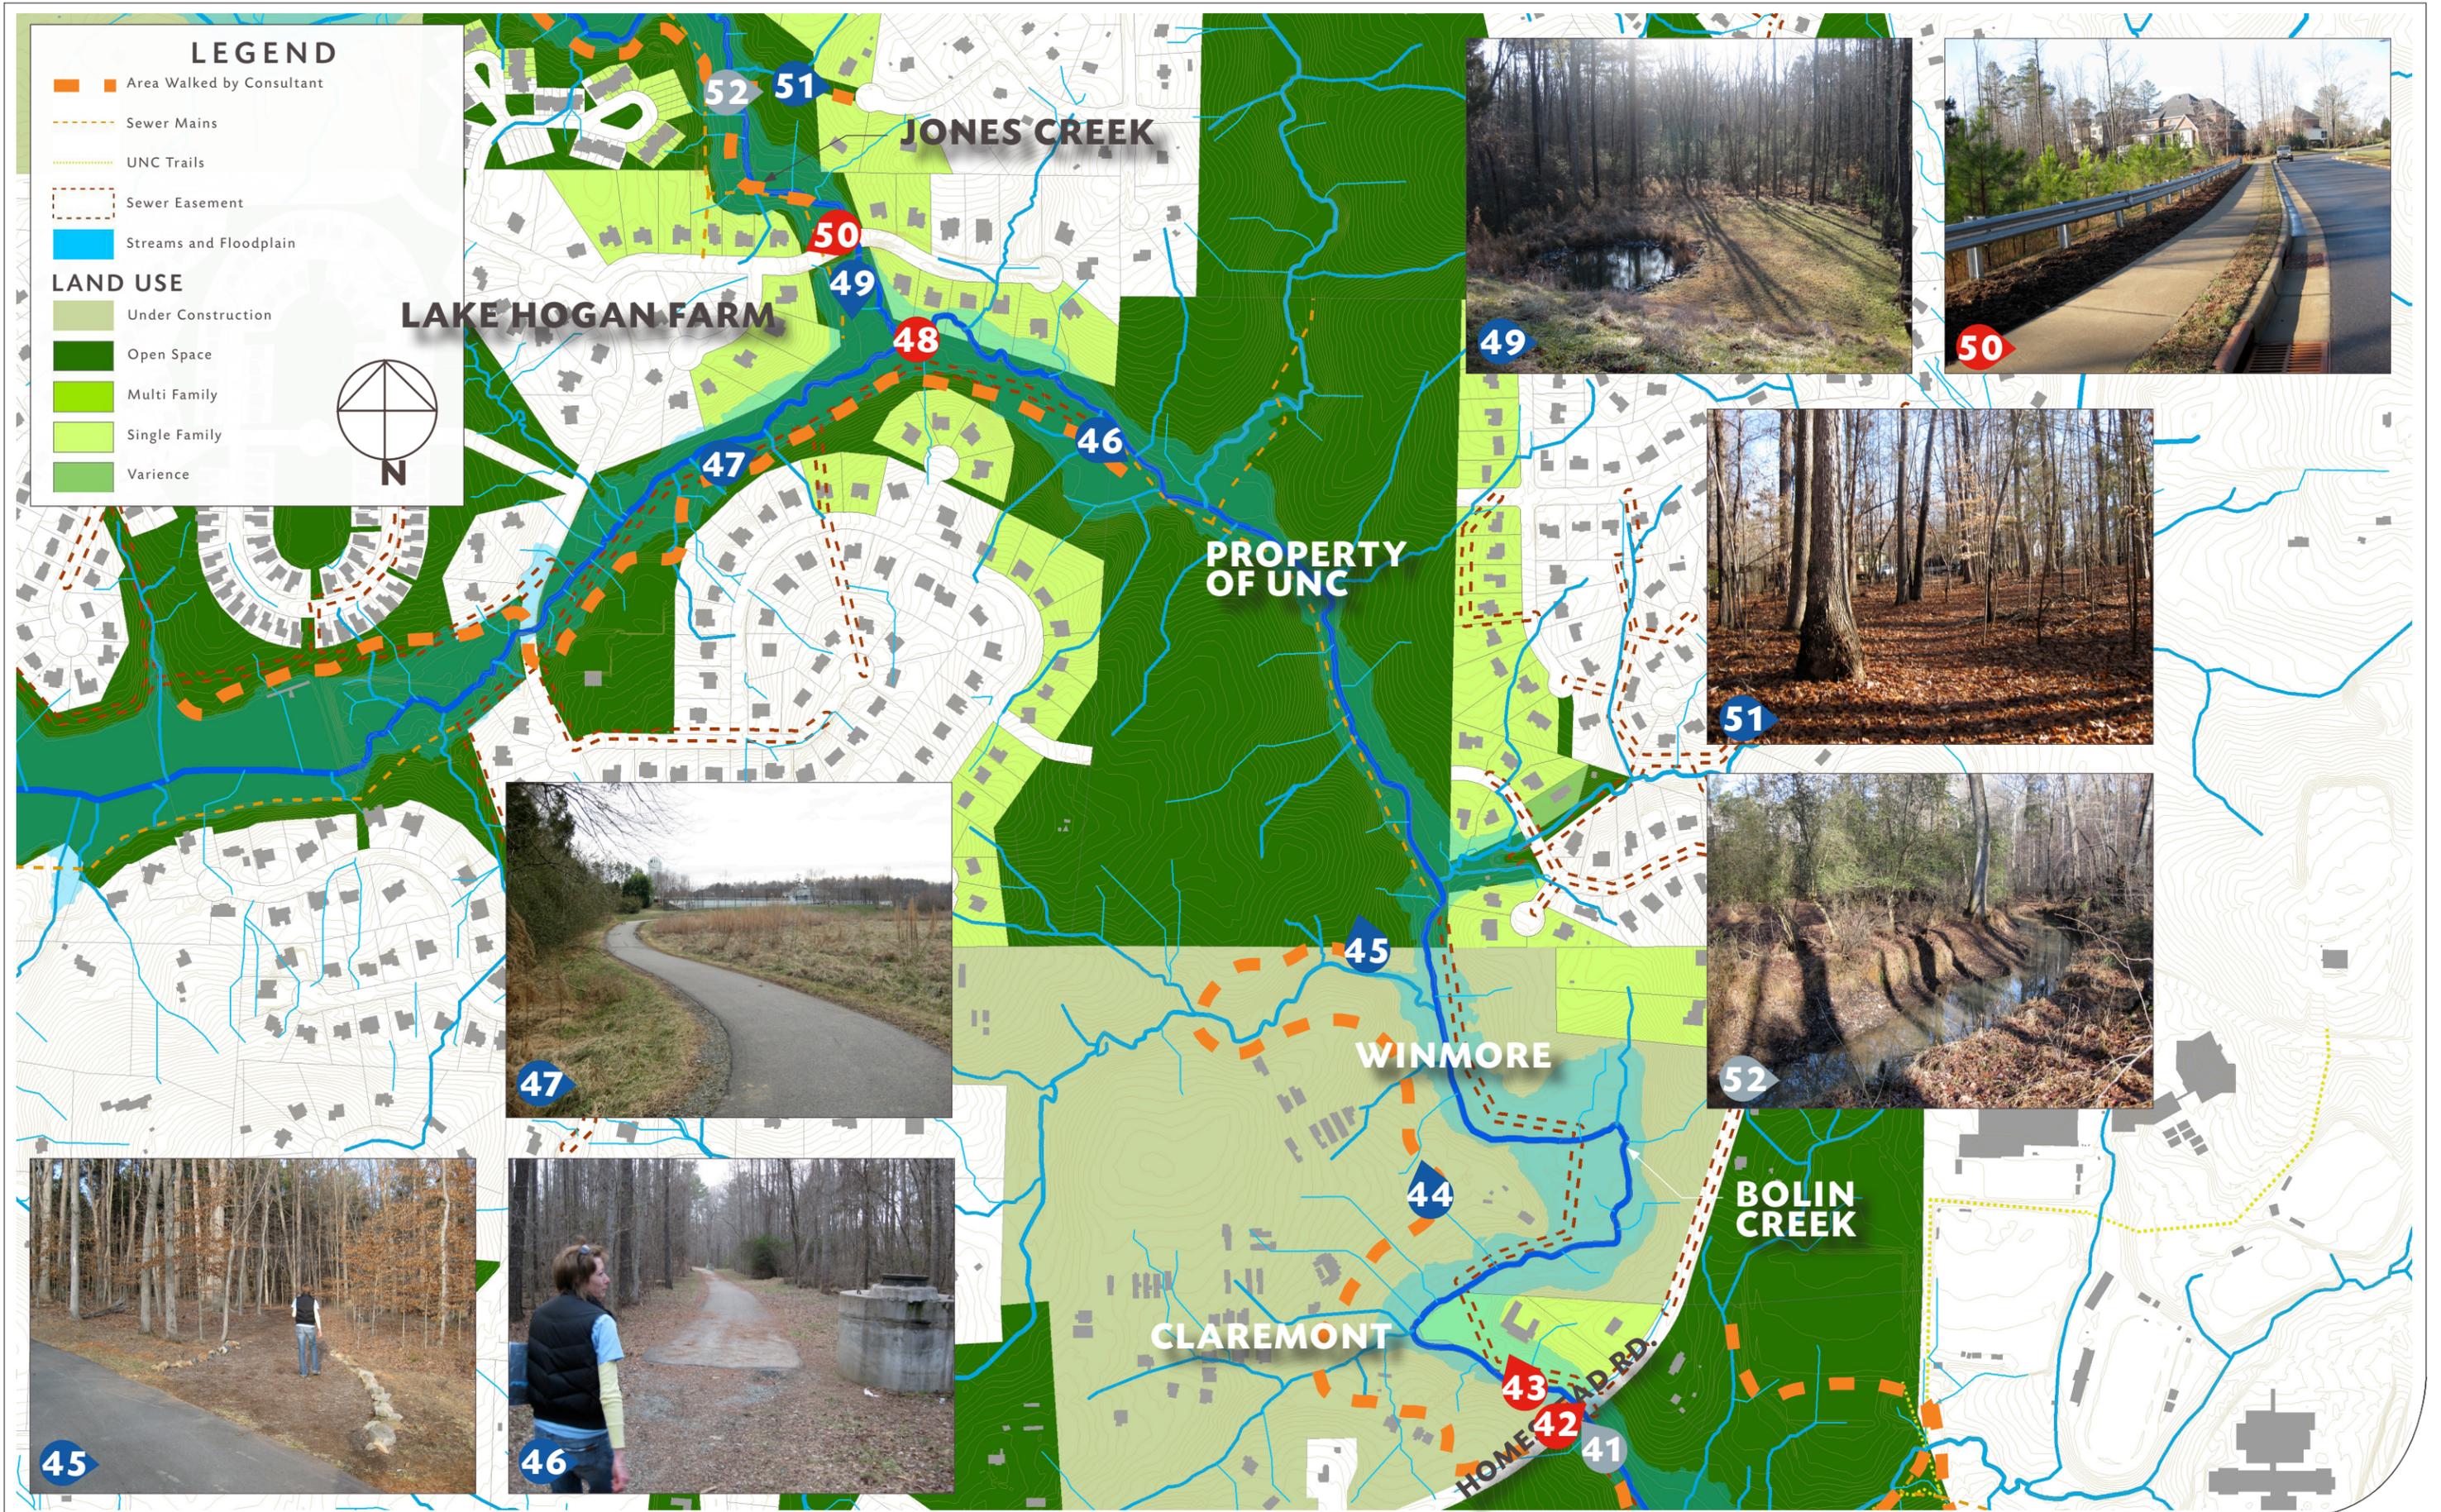
## Existing Conditions: Homestead Road to Jones Creek

- 41 Opportunity & Constraint:** Homestead Road’s roadway bridge offers approximately 8-feet of overhead clearance, making an underpass a possibility; however permitting and cost are constraints.

- 43 Constraint:** On the north side of Homestead Road, conditions continue to challenge trail crossing. Steep topography and limited land will require grading, tree removal, and cost-impacting structures.

- 49 Opportunity:** Trail alignment on the south side of Jones Creek is more practical from a topographical and connection standpoint.
- 50 Constraint:** An at-grade trail crossing will be necessary to cross the creek and road, presenting the possibility of neighborhood resistance and cost constraints.

- 51 Opportunity:** A foot trail spur up to the Tallyho neighborhood could provide access to trail opportunity down at Jones Creek.
- 52 Opportunity & Constraint:** In order to provide access to Tallyho residents, a crossing will be necessary at this location which could present permitting and cost constraints.

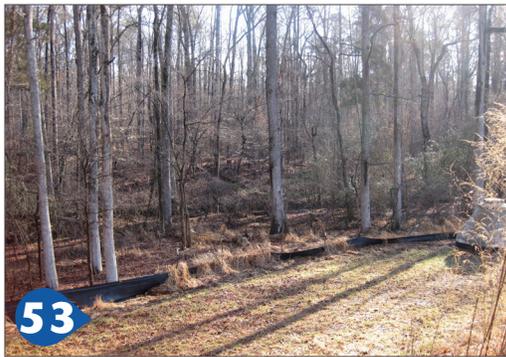
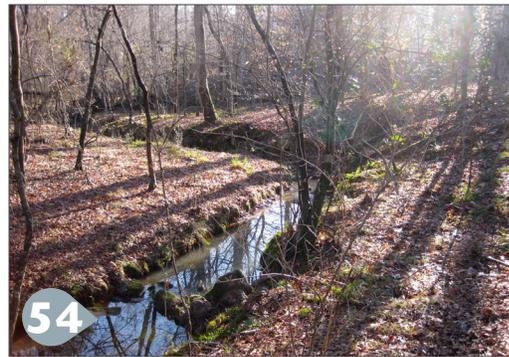
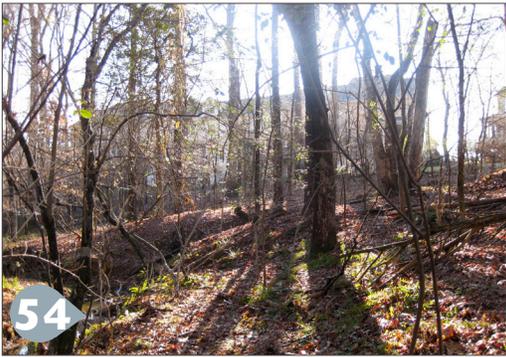
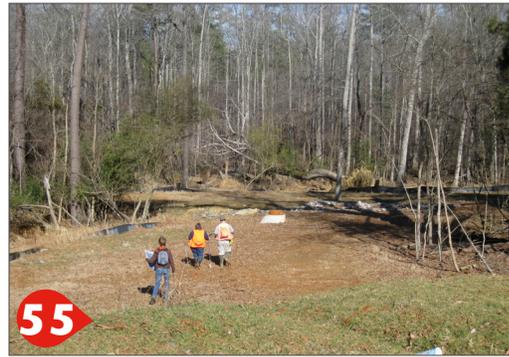
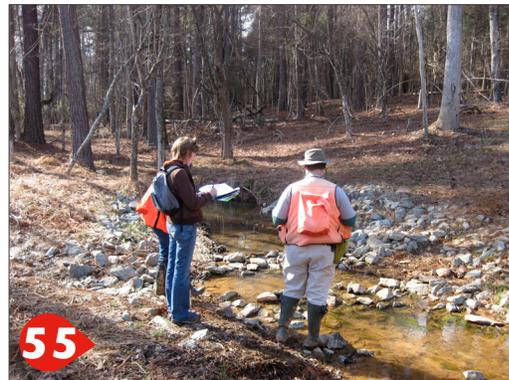
**53 Opportunity:** Open cleared conditions behind the townhomes in Lake Hogan Farm offer feasible trail conditions on the southern side of Jones Creek.

**54 Opportunity & Constraint:** Creek conditions are relatively flat and will still permit south side alignment; however steeper topography gradually overwhelms the corridor, creating conditions that will require grading and retaining walls.

**55 Constraint:** Property constraints, costly creek crossings and accessibility make this area a challenge for the Jones Creek corridor.

**56 Opportunity & Constraint:** Existing sewer easement continues north to Morris Grove Elementary School, and with proposed trail, could provide non-motorized transportation for children; however several tributary crossings will require permits and bridge crossings along the corridor.
