**BIOLOGICAL MONITORING OF
BOLIN CREEK
CARRBORO, NORTH CAROLINA**

JULY 2009 SURVEY

**LENAT CONSULTING SERVICES
3607 CORBIN STREET
RALEIGH NC 27612
919-787-80897
LENATBKS@MINDSPRING.COM**

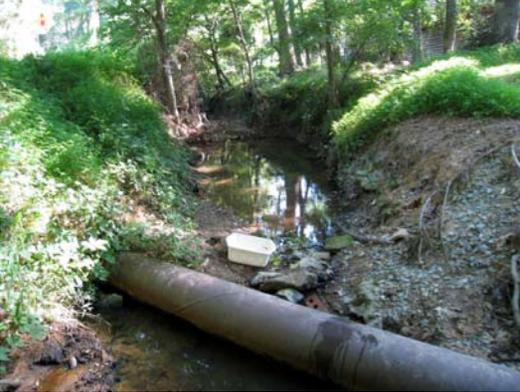
Toms Creek Site 1, July 2009.

Toms Creek 1. Site 1 was located just upstream Main Street in Carrboro, but with access from Lorraine Street. This site drains a largely residential area, although there was usually some buffer zone next to the stream. The stream was highly entrenched and may have been channelized in the past to install the adjacent sewer line.

Flow was barely discernable in this part of Toms Creek and this segment may go completely dry during the summer. Width was about 0.2 meters in flowing areas, and about 1.5 meters in pools. There was severe bank erosion in some areas. Substrate was mostly gravel in flowing segments, but there were some areas with boulder and rubble.

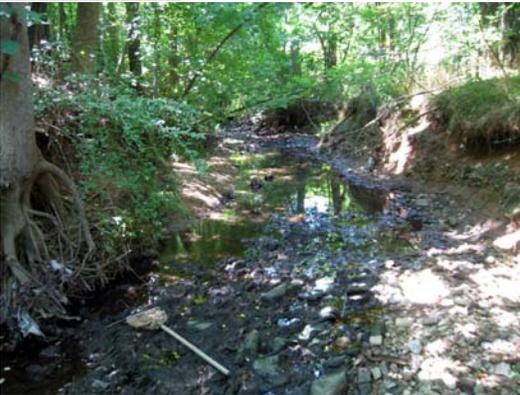
Toms Creek Site 2, July 2009.

Toms Creek 2. Site 2 is located downstream of Berryhill Drive and the Rosewalk development.

There is greater flow here than at Toms Creek Site 1, but mean width is still only 2 meters. The substrate is mostly rubble and boulder (70%), but areas of sand deposition were observed along the bank. This part of Toms Creek is deeply entrenched, with severe bank erosion. There is a good buffer zone at this site, but very little buffer was observed at residential areas further upstream in this catchment.

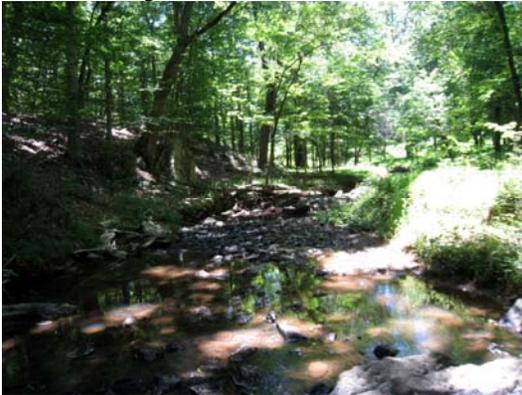
Morgan Creek, Dairyland Rd, July 2009

Morgan Creek 1 at Dairyland Rd. In an attempt to find a better reference, Morgan Creek was examined at 2 sites on Dairyland Road. The most upstream site too small, but the downstream site had good flow and good habitat

Much of this segment was very low gradient, with low current speeds, but a good riffle area was found about 50 meters upstream of the culvert.

The catchment above this site includes some dairy operations, and some problems have been documented in the past.

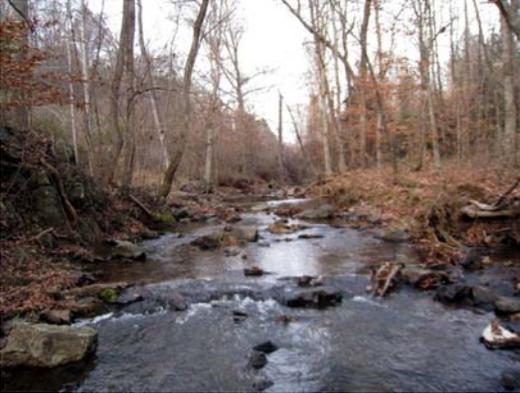
Morgan Creek, NC 54, December 2008.

Morgan Creek 2 at NC 54. Morgan Creek had been used as a reference site for our samples In December 2008, although this stream had also been affected by droughts. Prior surveys by the NC Division of Water Quality generally produced a Good or Excellent bioclassification for this site.

This catchment has a largely rural character, with some minor impacts from nonpoint source runoff. Habitat quality, stream width and substrate composition are similar to Bollin Creek, but with less residential land use.
